Masonry Mysteries

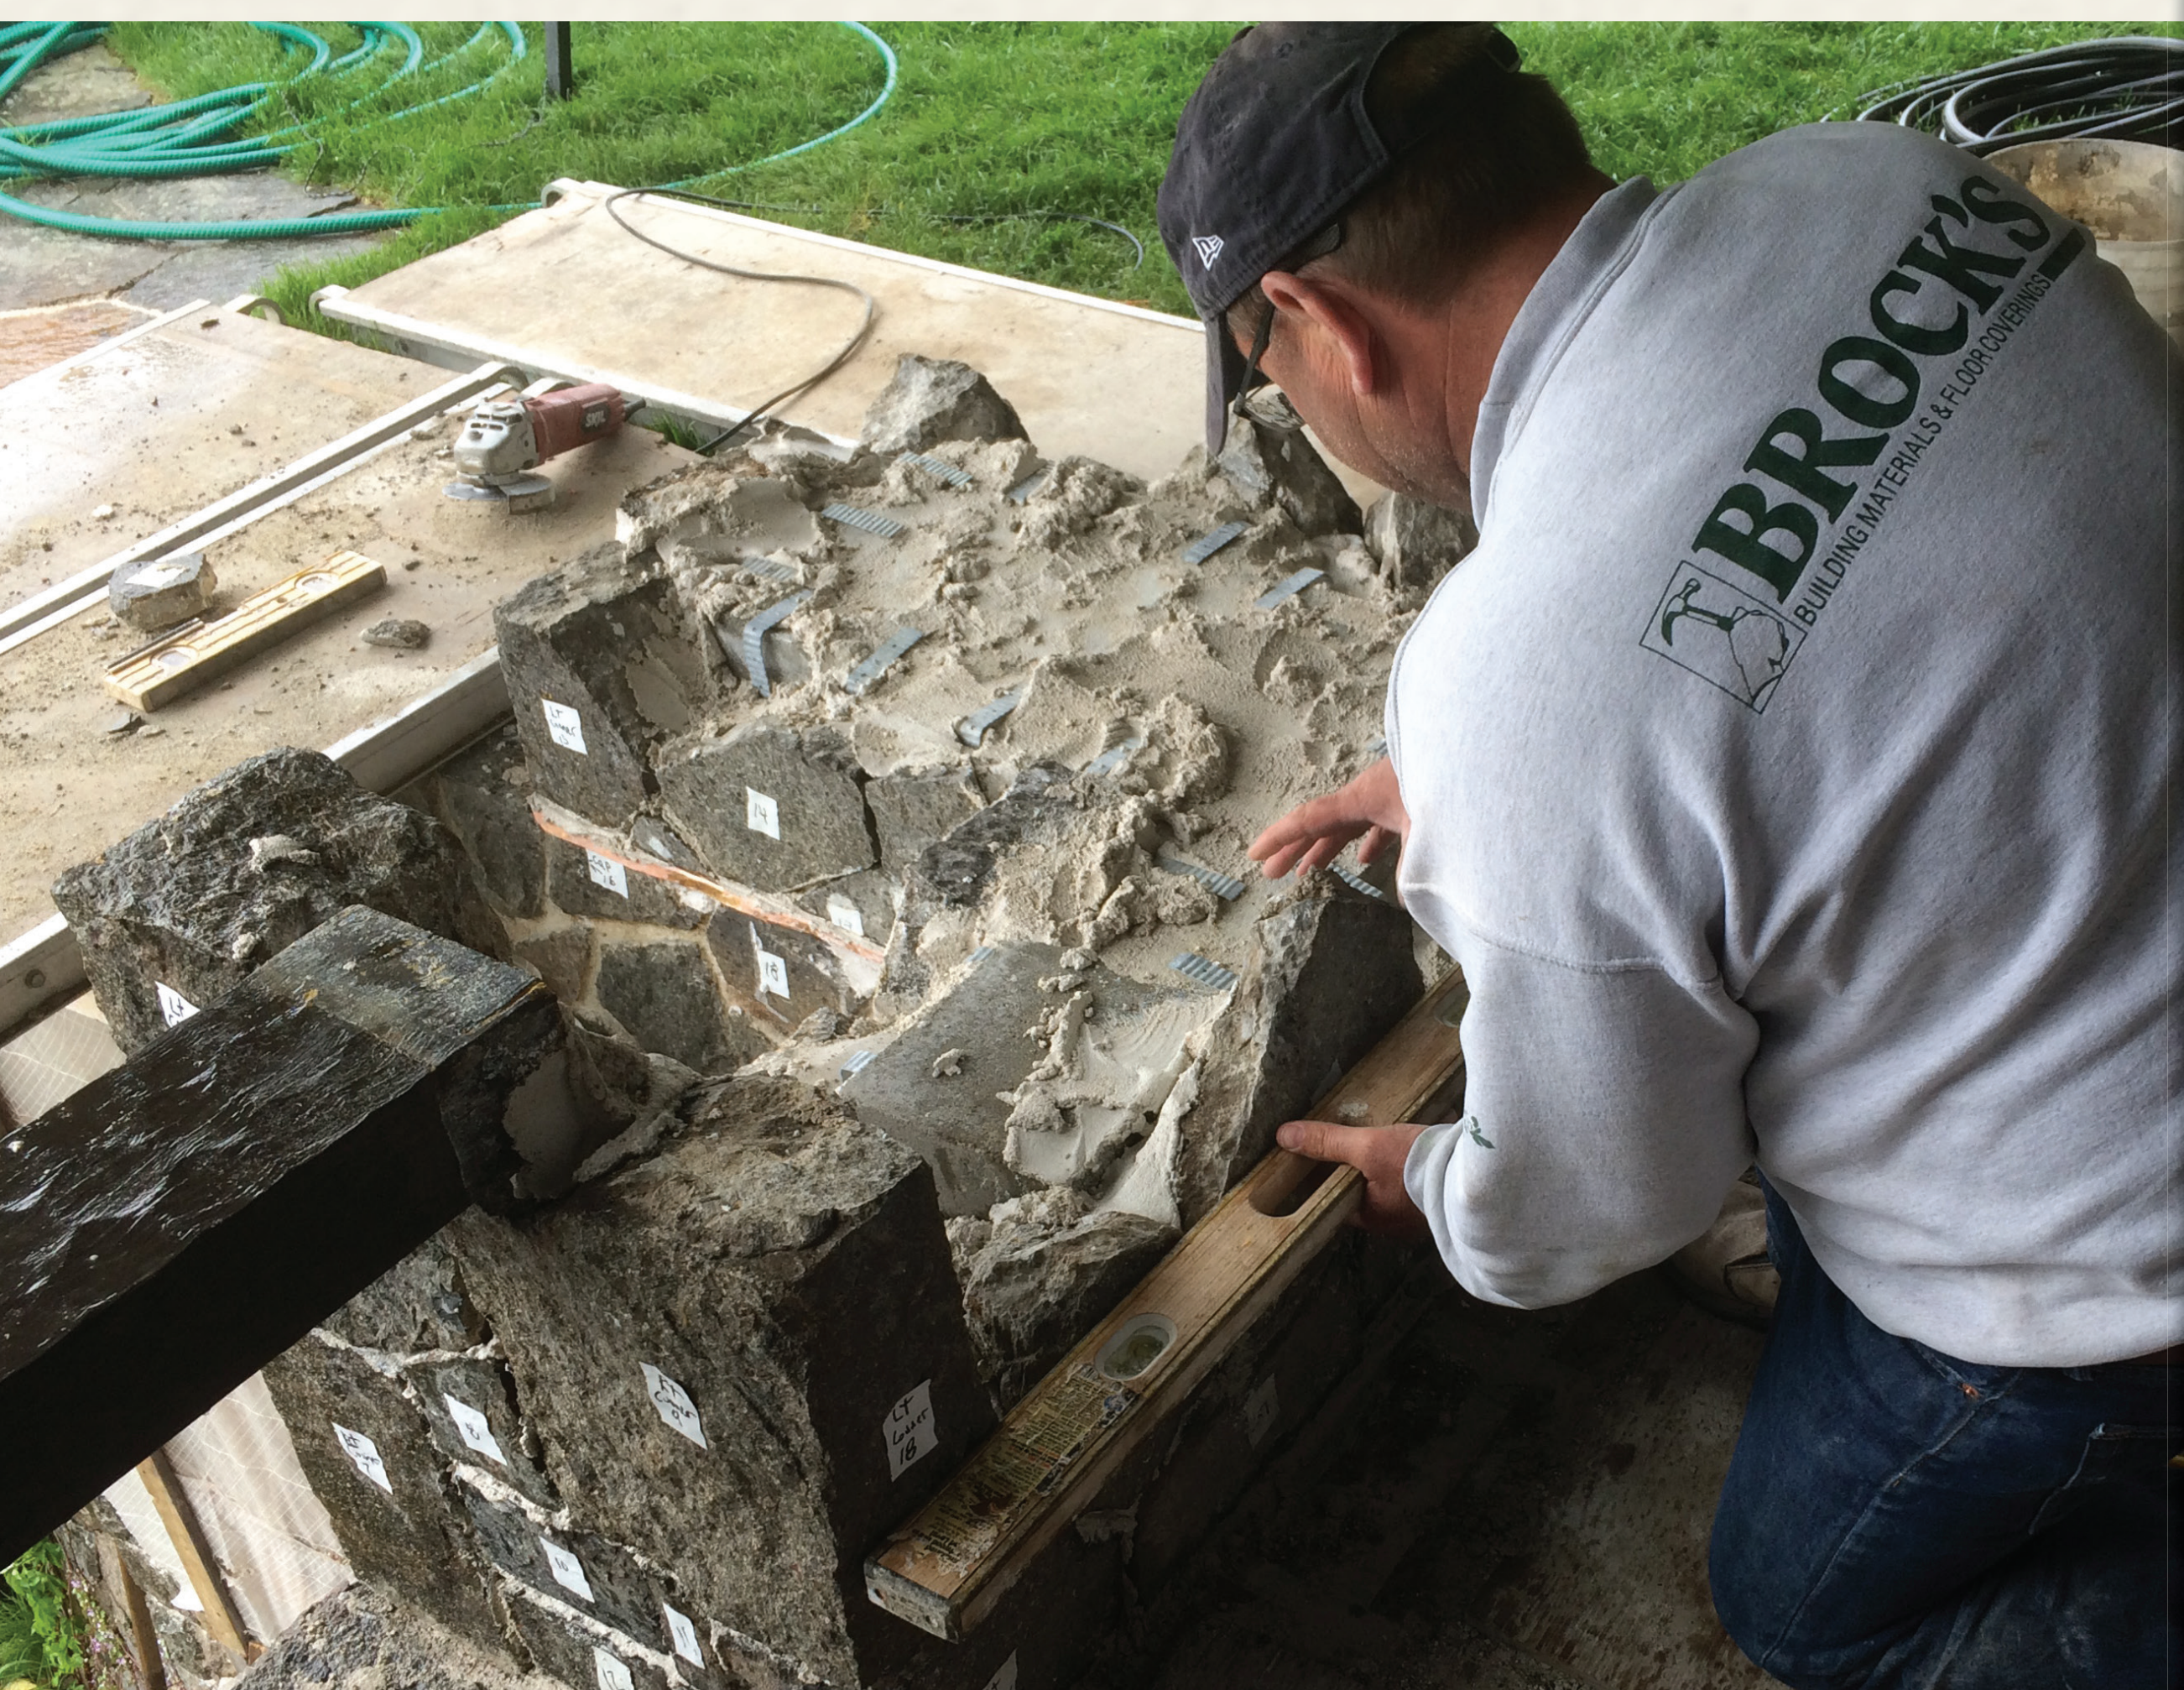
Tom Ahearn of Stepping Stones Masonry restoring a stone stanchion outside the Castle's sun parlor.
