Cleaning and Conserving the Refrigeration System

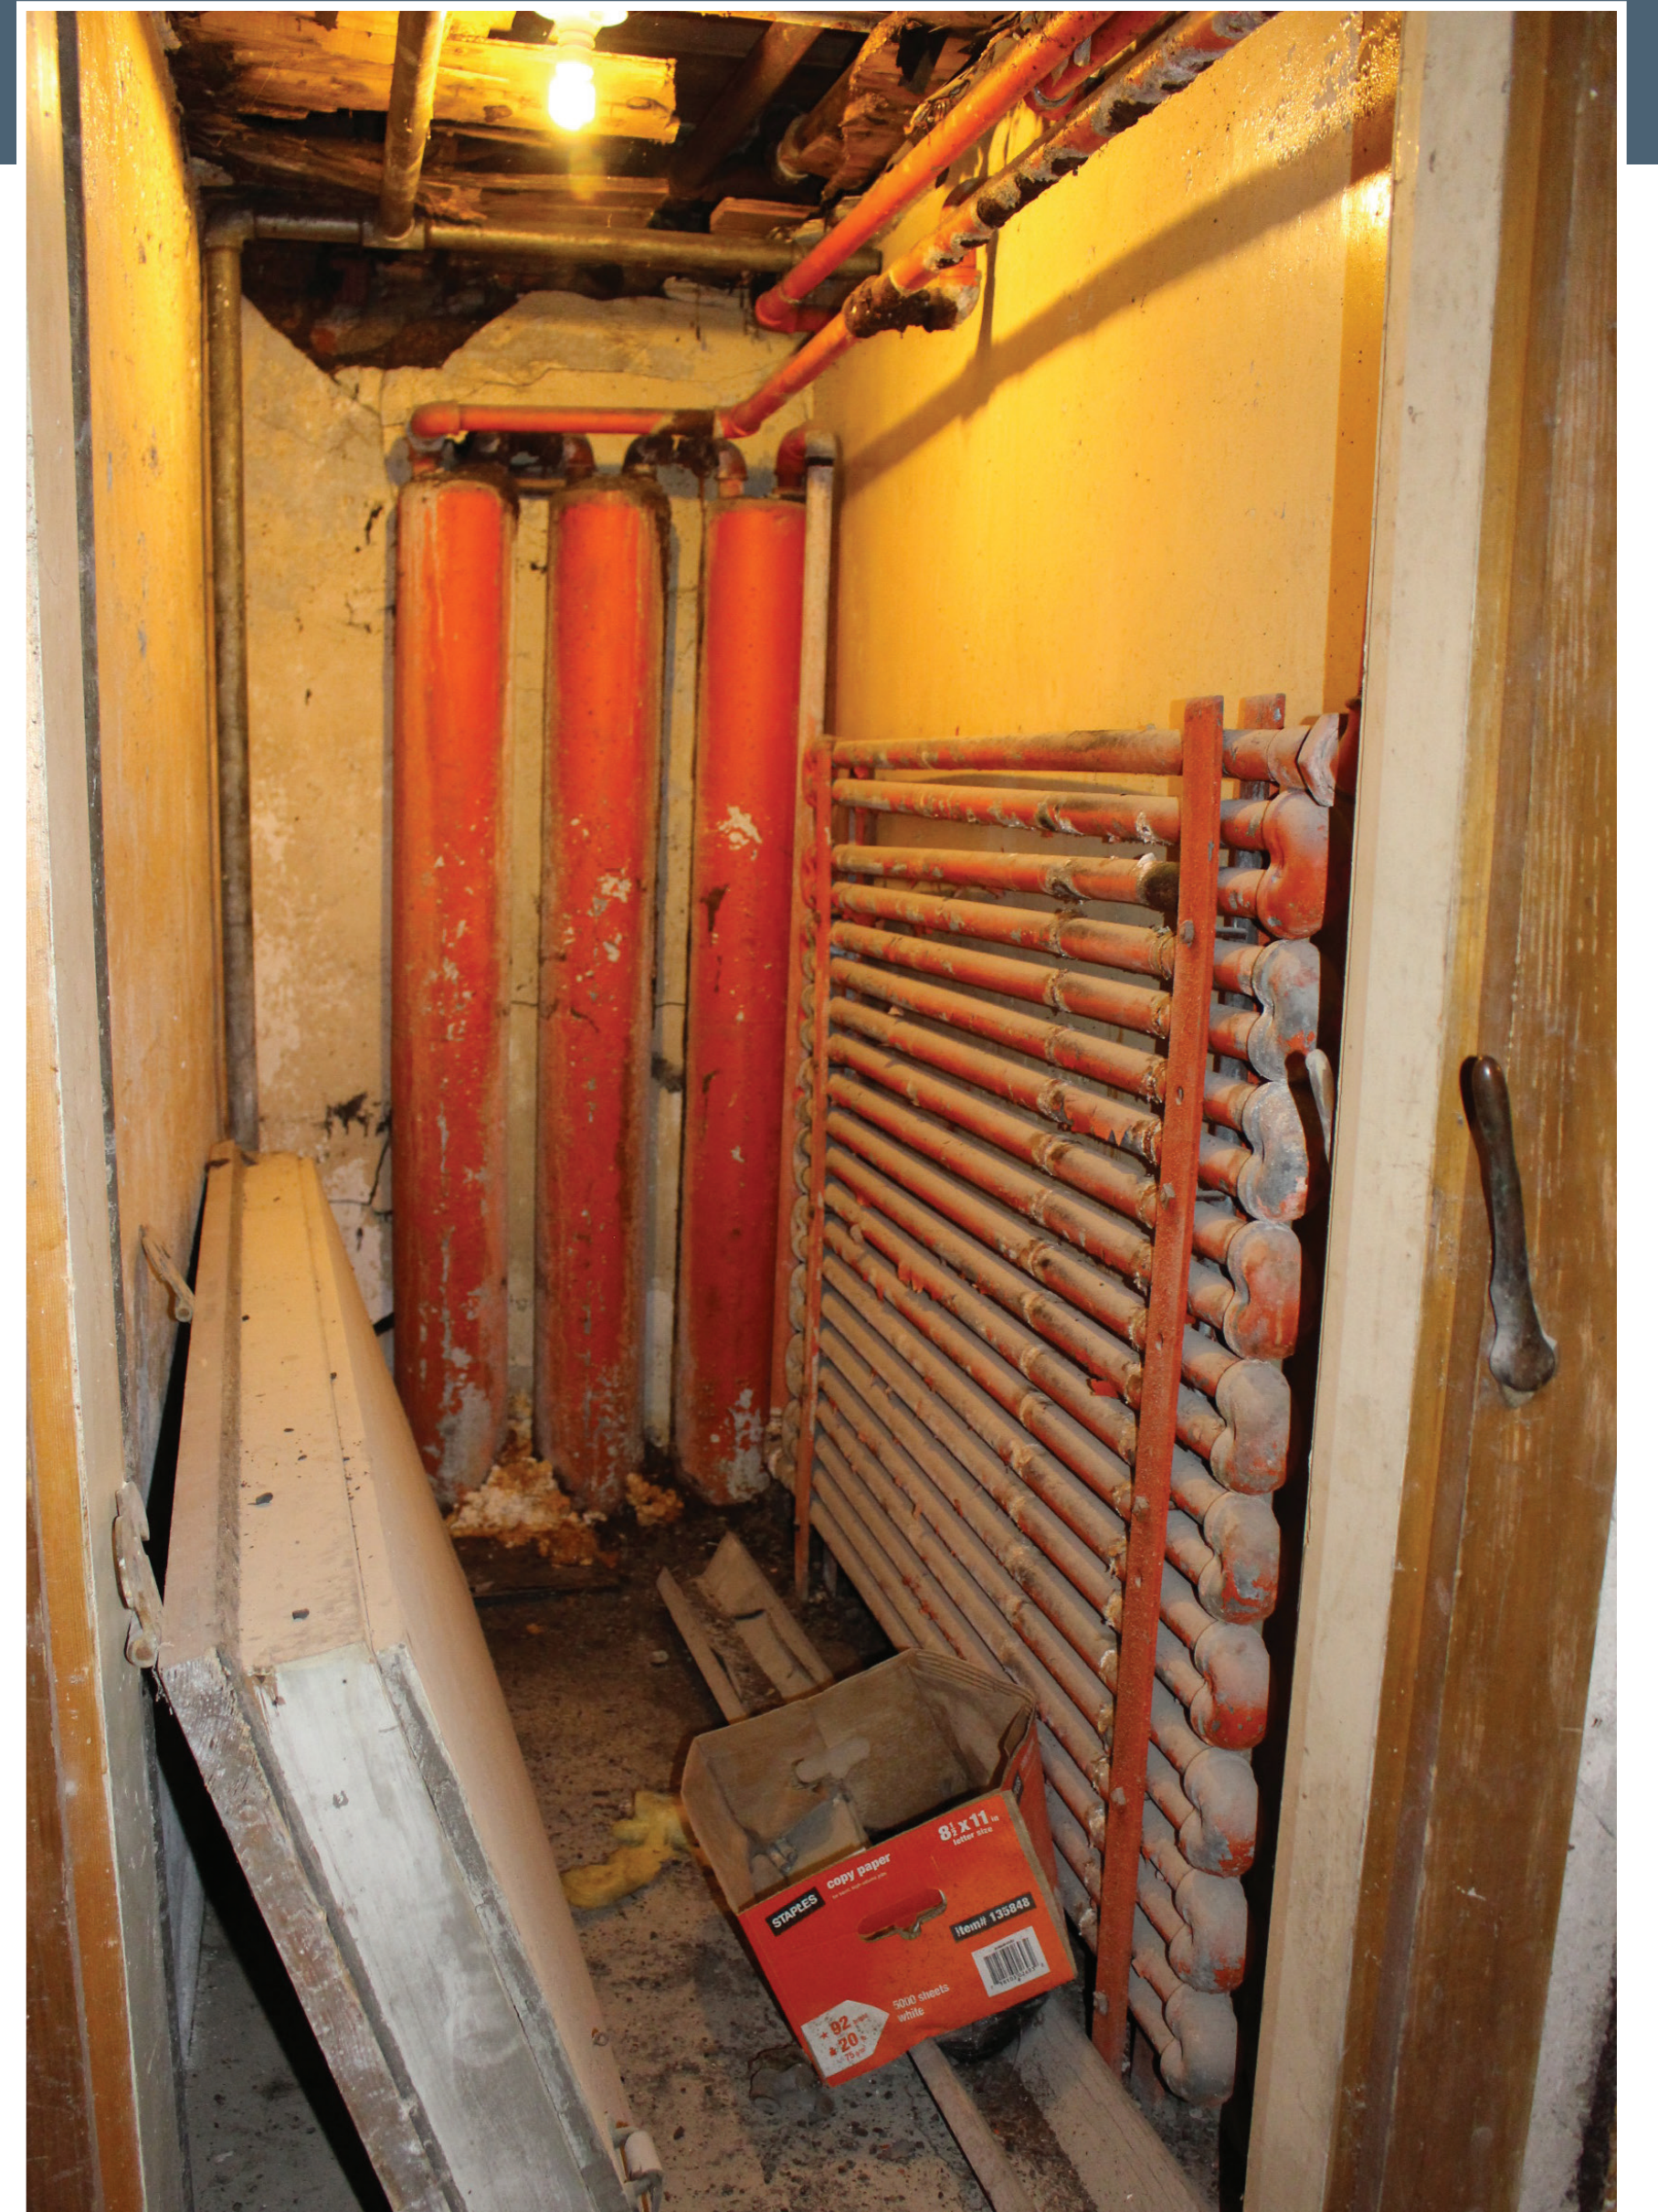
above | A walk-in refrigerator in the basement, before restoration, 2017.

The major components of the Castle's sophisticated ammonia brine refrigeration system are still in place in the basement today. The unit was no longer functioning by the time the Tobey family was living in the house in the 1940s and 1950s, and by 2017, it had corroded so badly that holding tanks were oozing what remained of the system's ammonia. The Blackburn conservation team drilled tiny holes in the bottoms of the tanks and emptied them of their century old ammonia (which had turned into a thick black sludge).

Once emptied of ammonia, surface corrosion was cleaned from the metal tanks and piping in the basement's refrigeration closets, as well as in the two refrigerators on the home's first floor. The original bright orange paint was replicated and these parts were given a new coating to protect them from future rust.

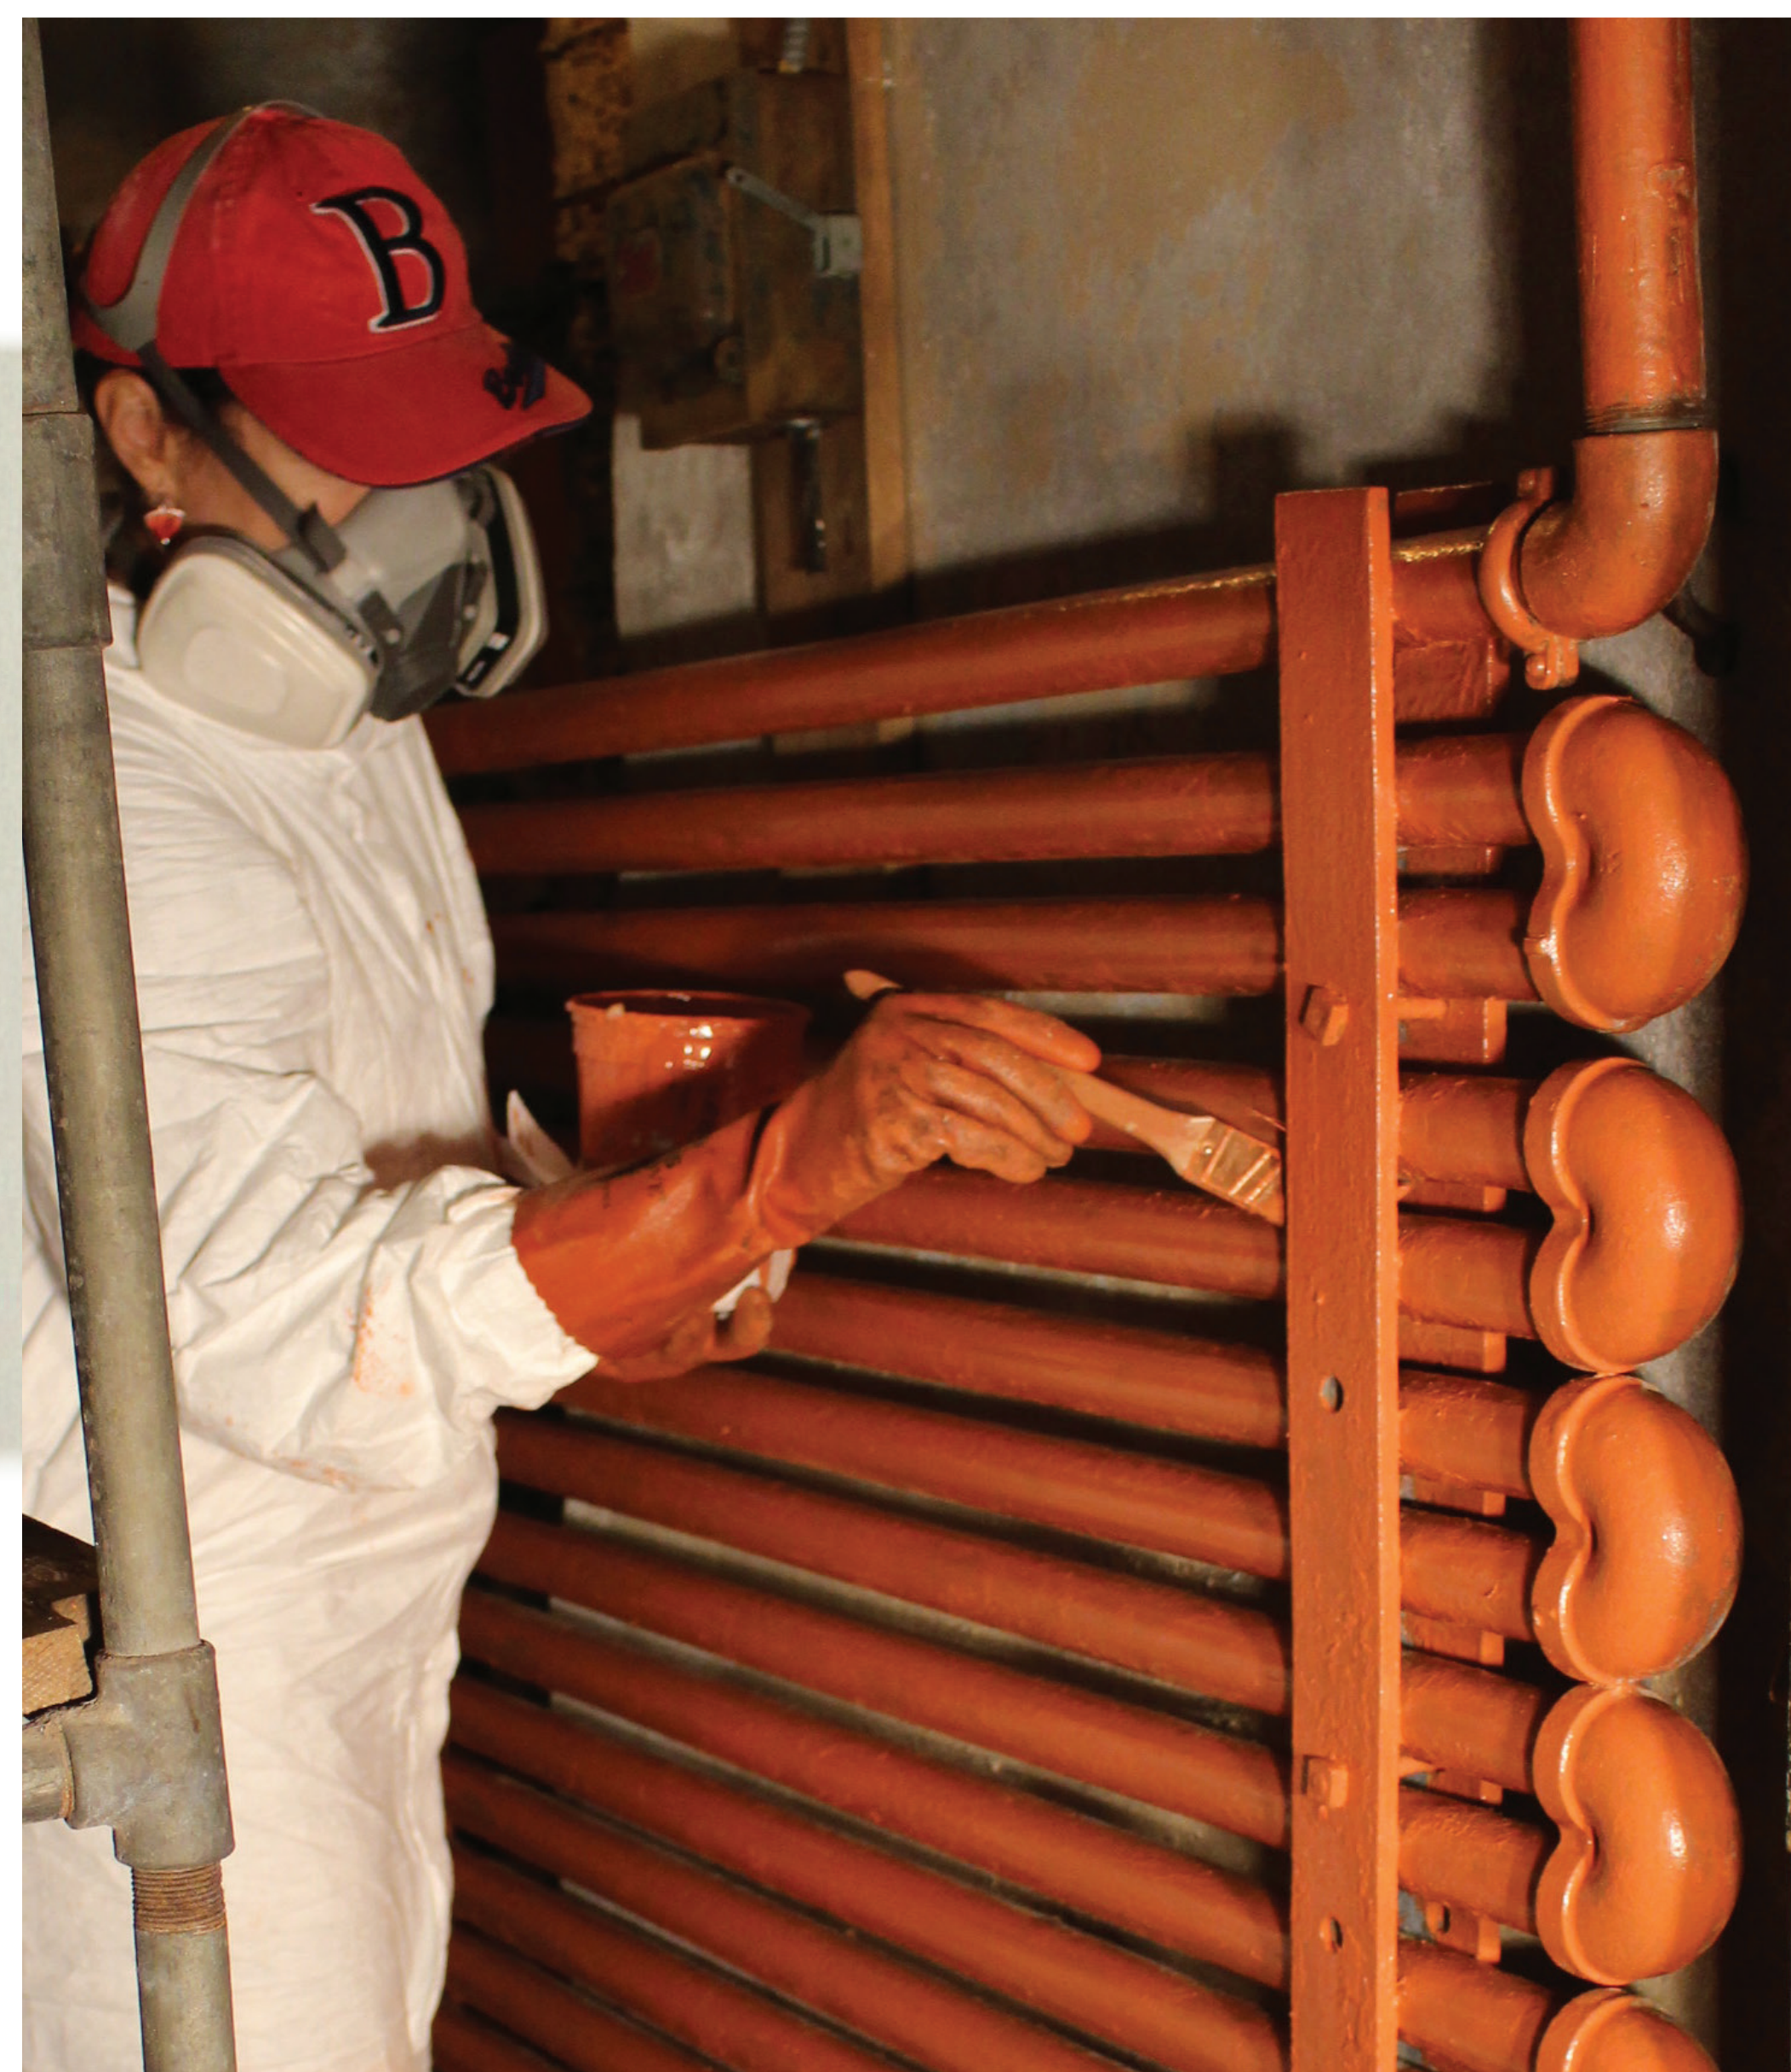
below | A conservator from Blackburn Building Conservation painting refrigeration piping to match the original color, 2017.

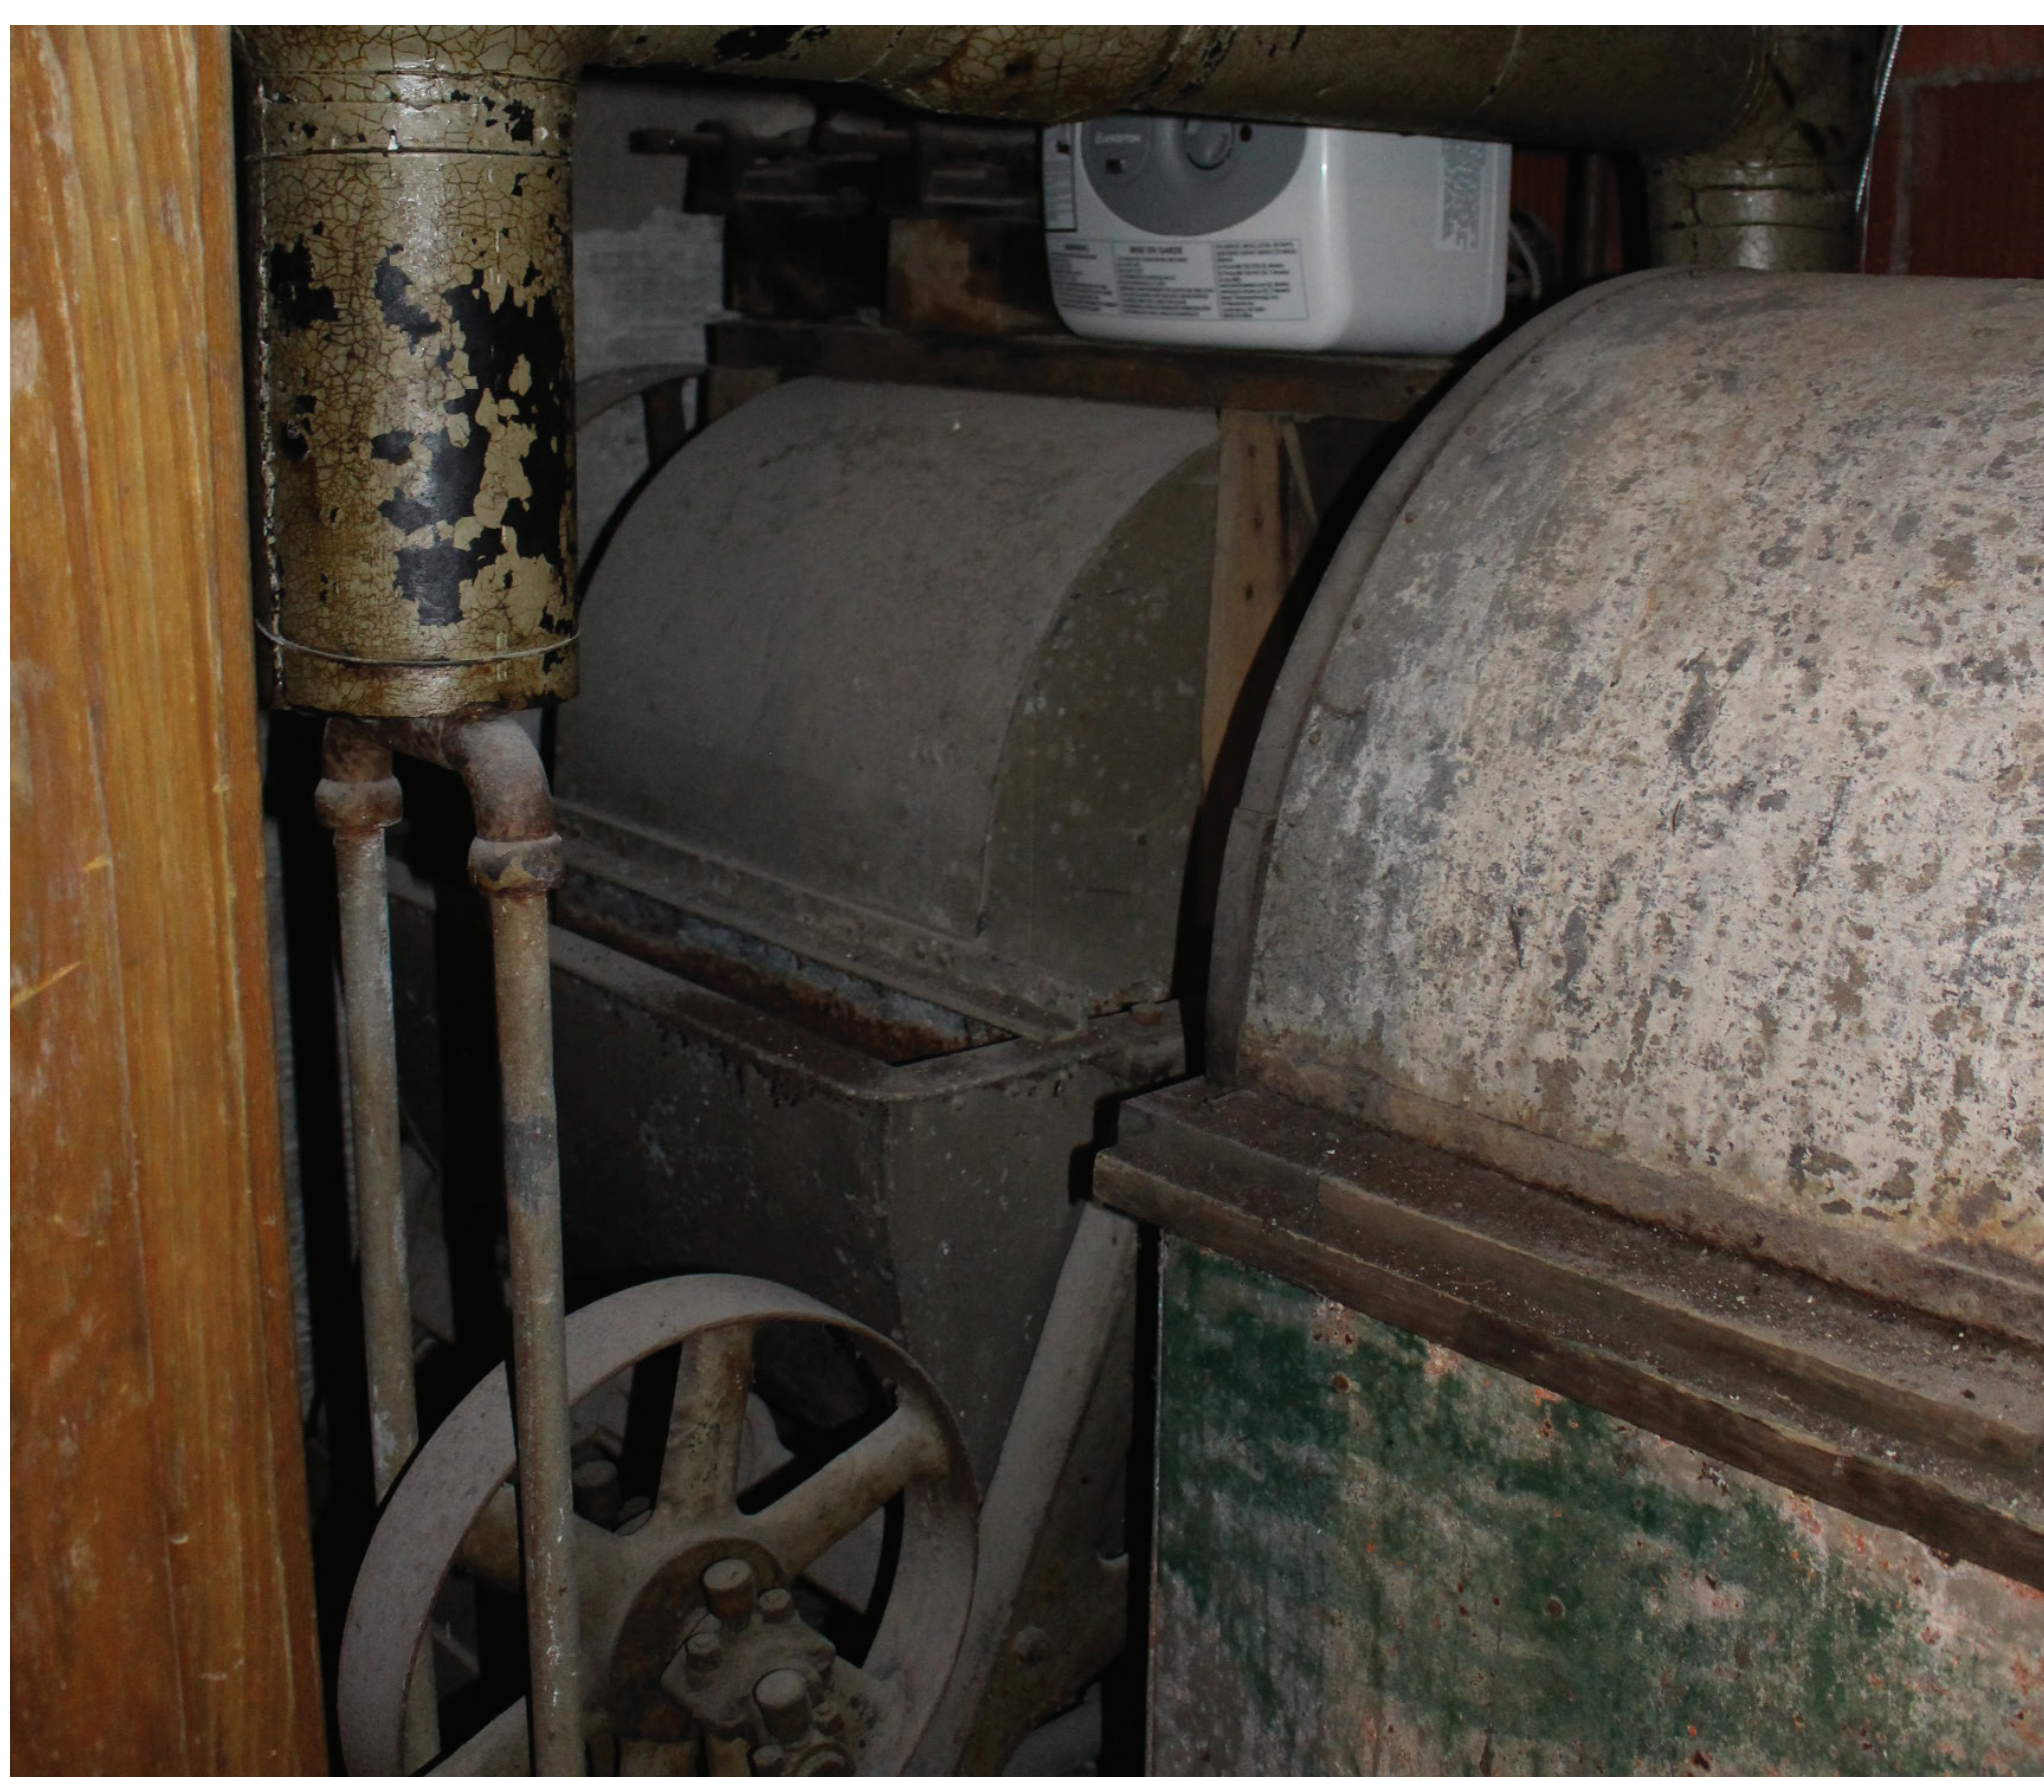
The Castle's refrigeration motor and brine tank, before restoration, 2017.

The system's large brine tank was similarly cleaned and its original green paint was reproduced.
