Restoring Lucknow's Historic Timbers

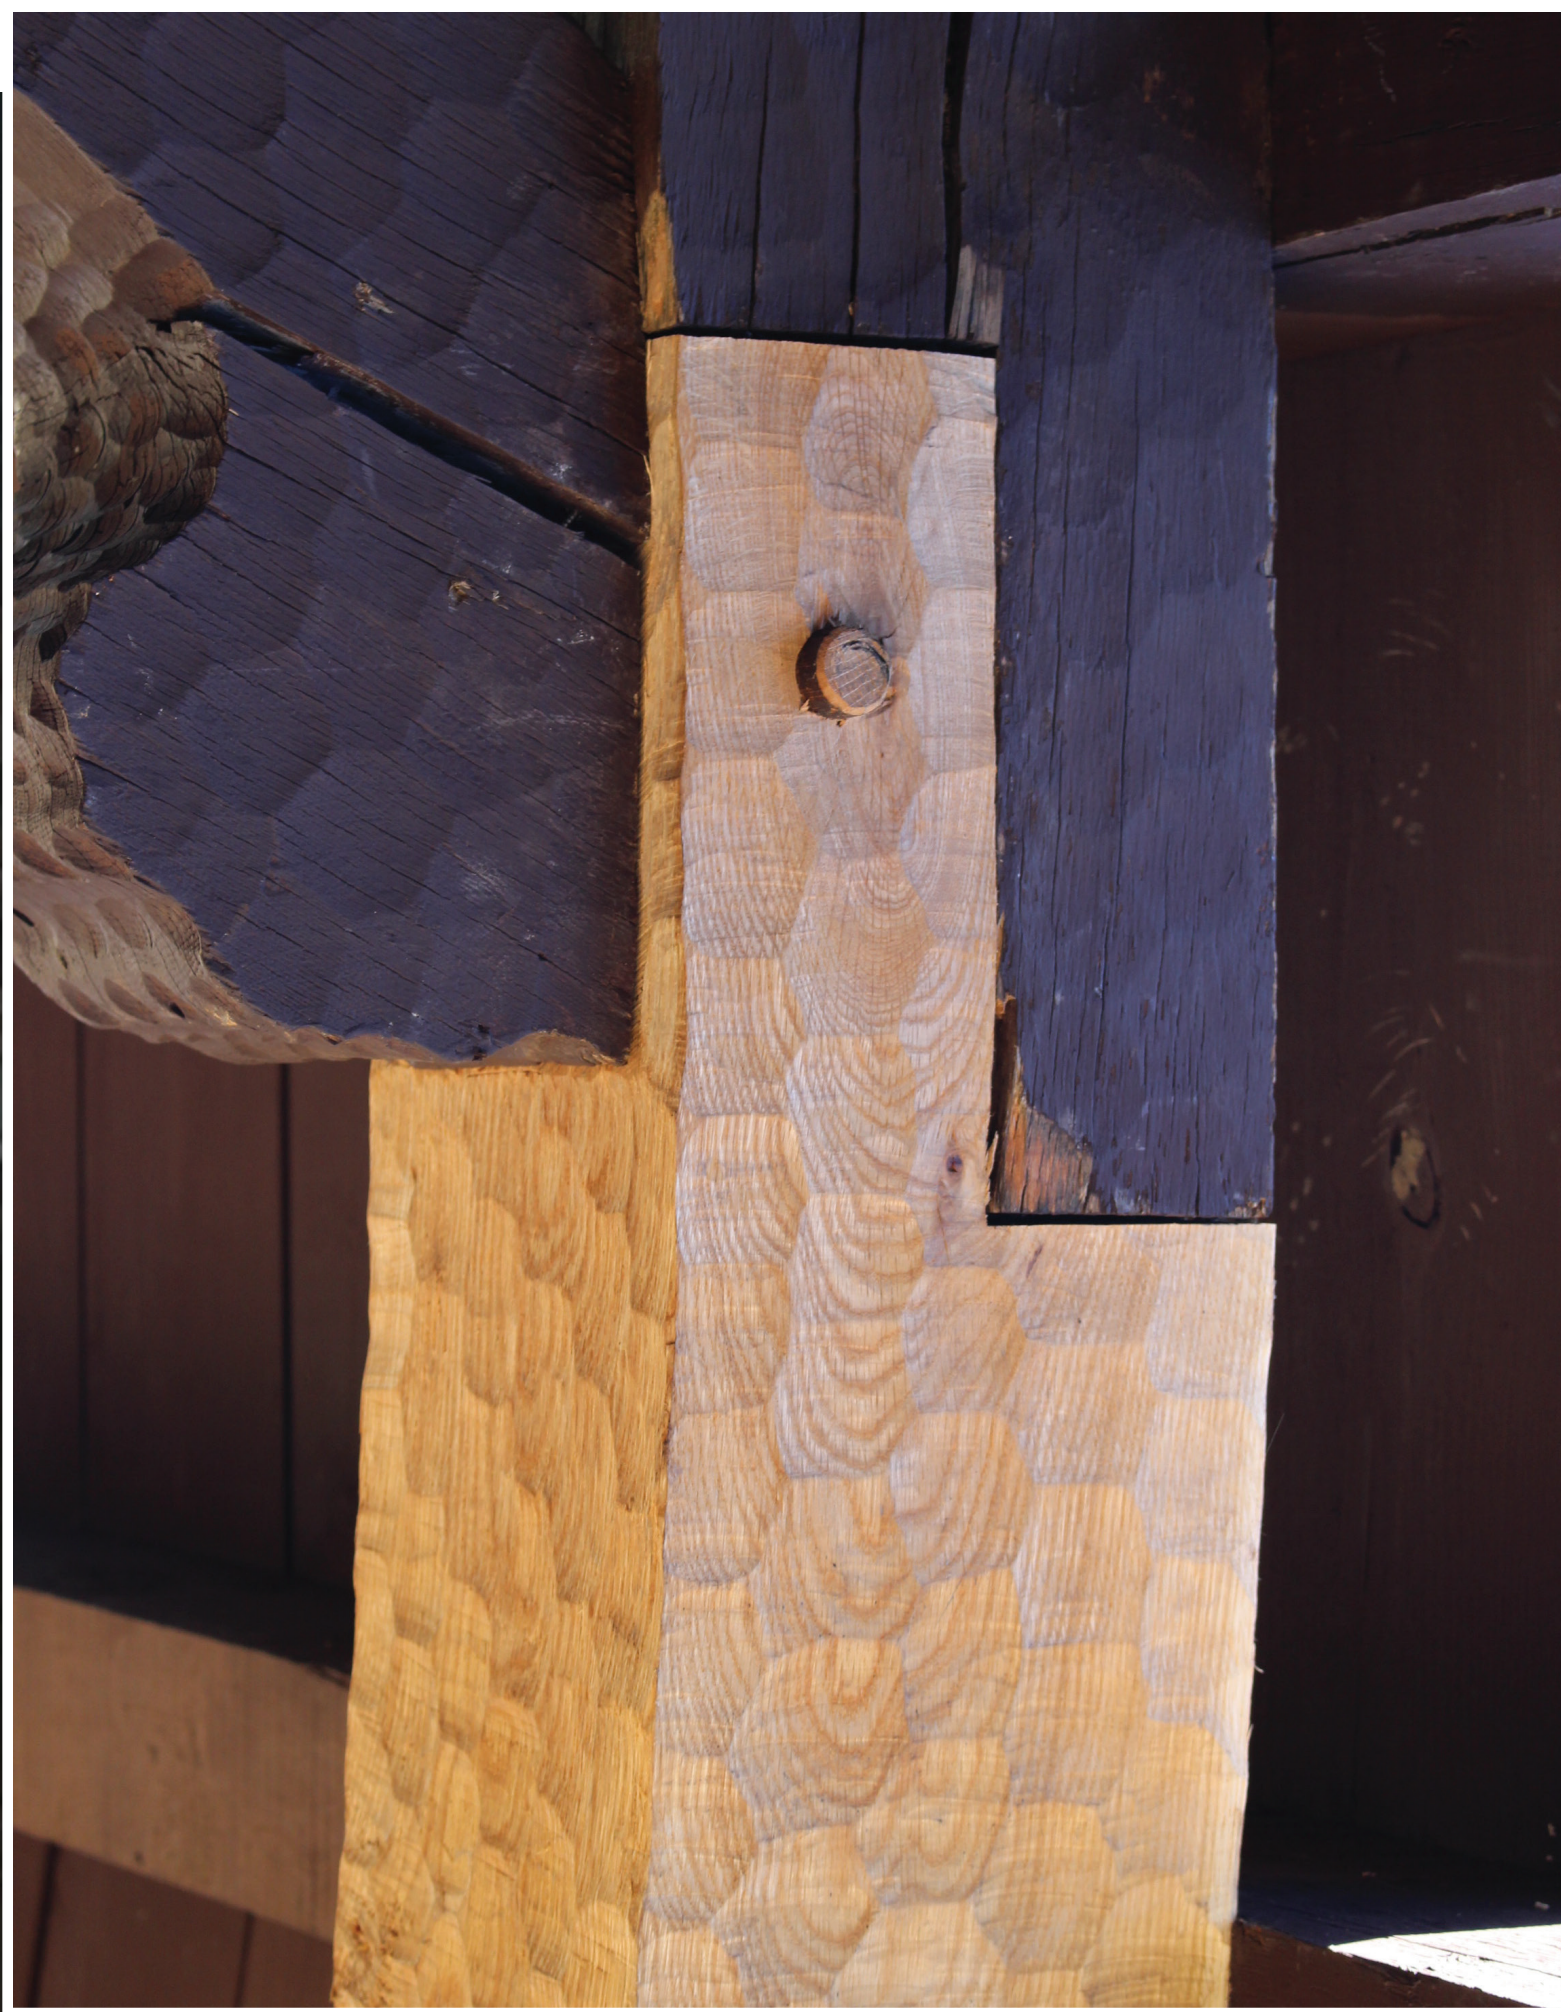
above | A pergola post gets a new section of white oak to replace a rotted area. The original is joined with the new and secured with a dowel, 2017.

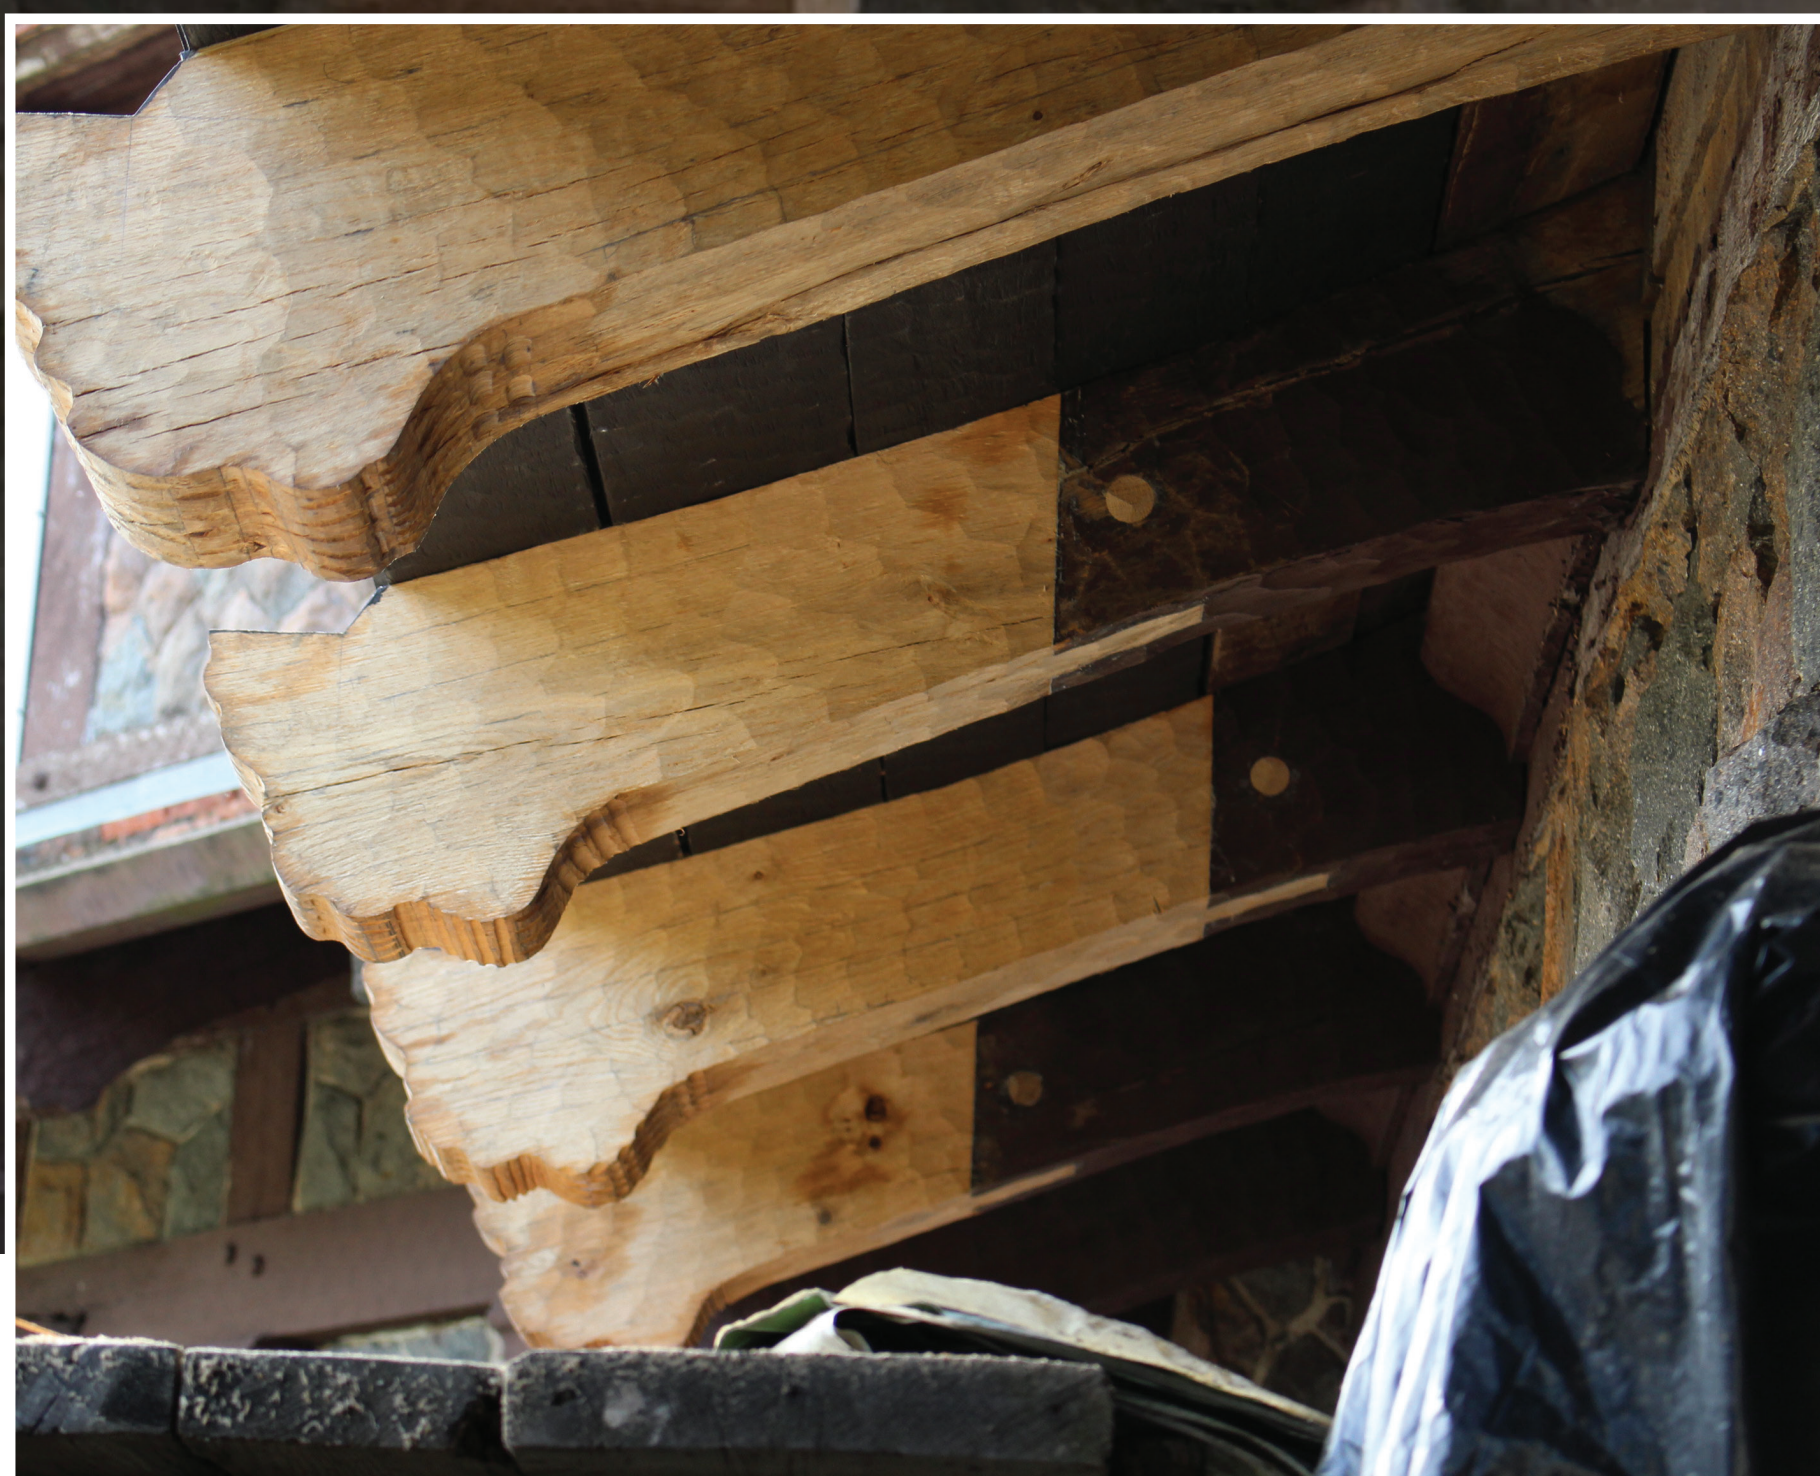
below | New rafter tails installed using mortise and tenon joinery and secured with dowels, 2017.

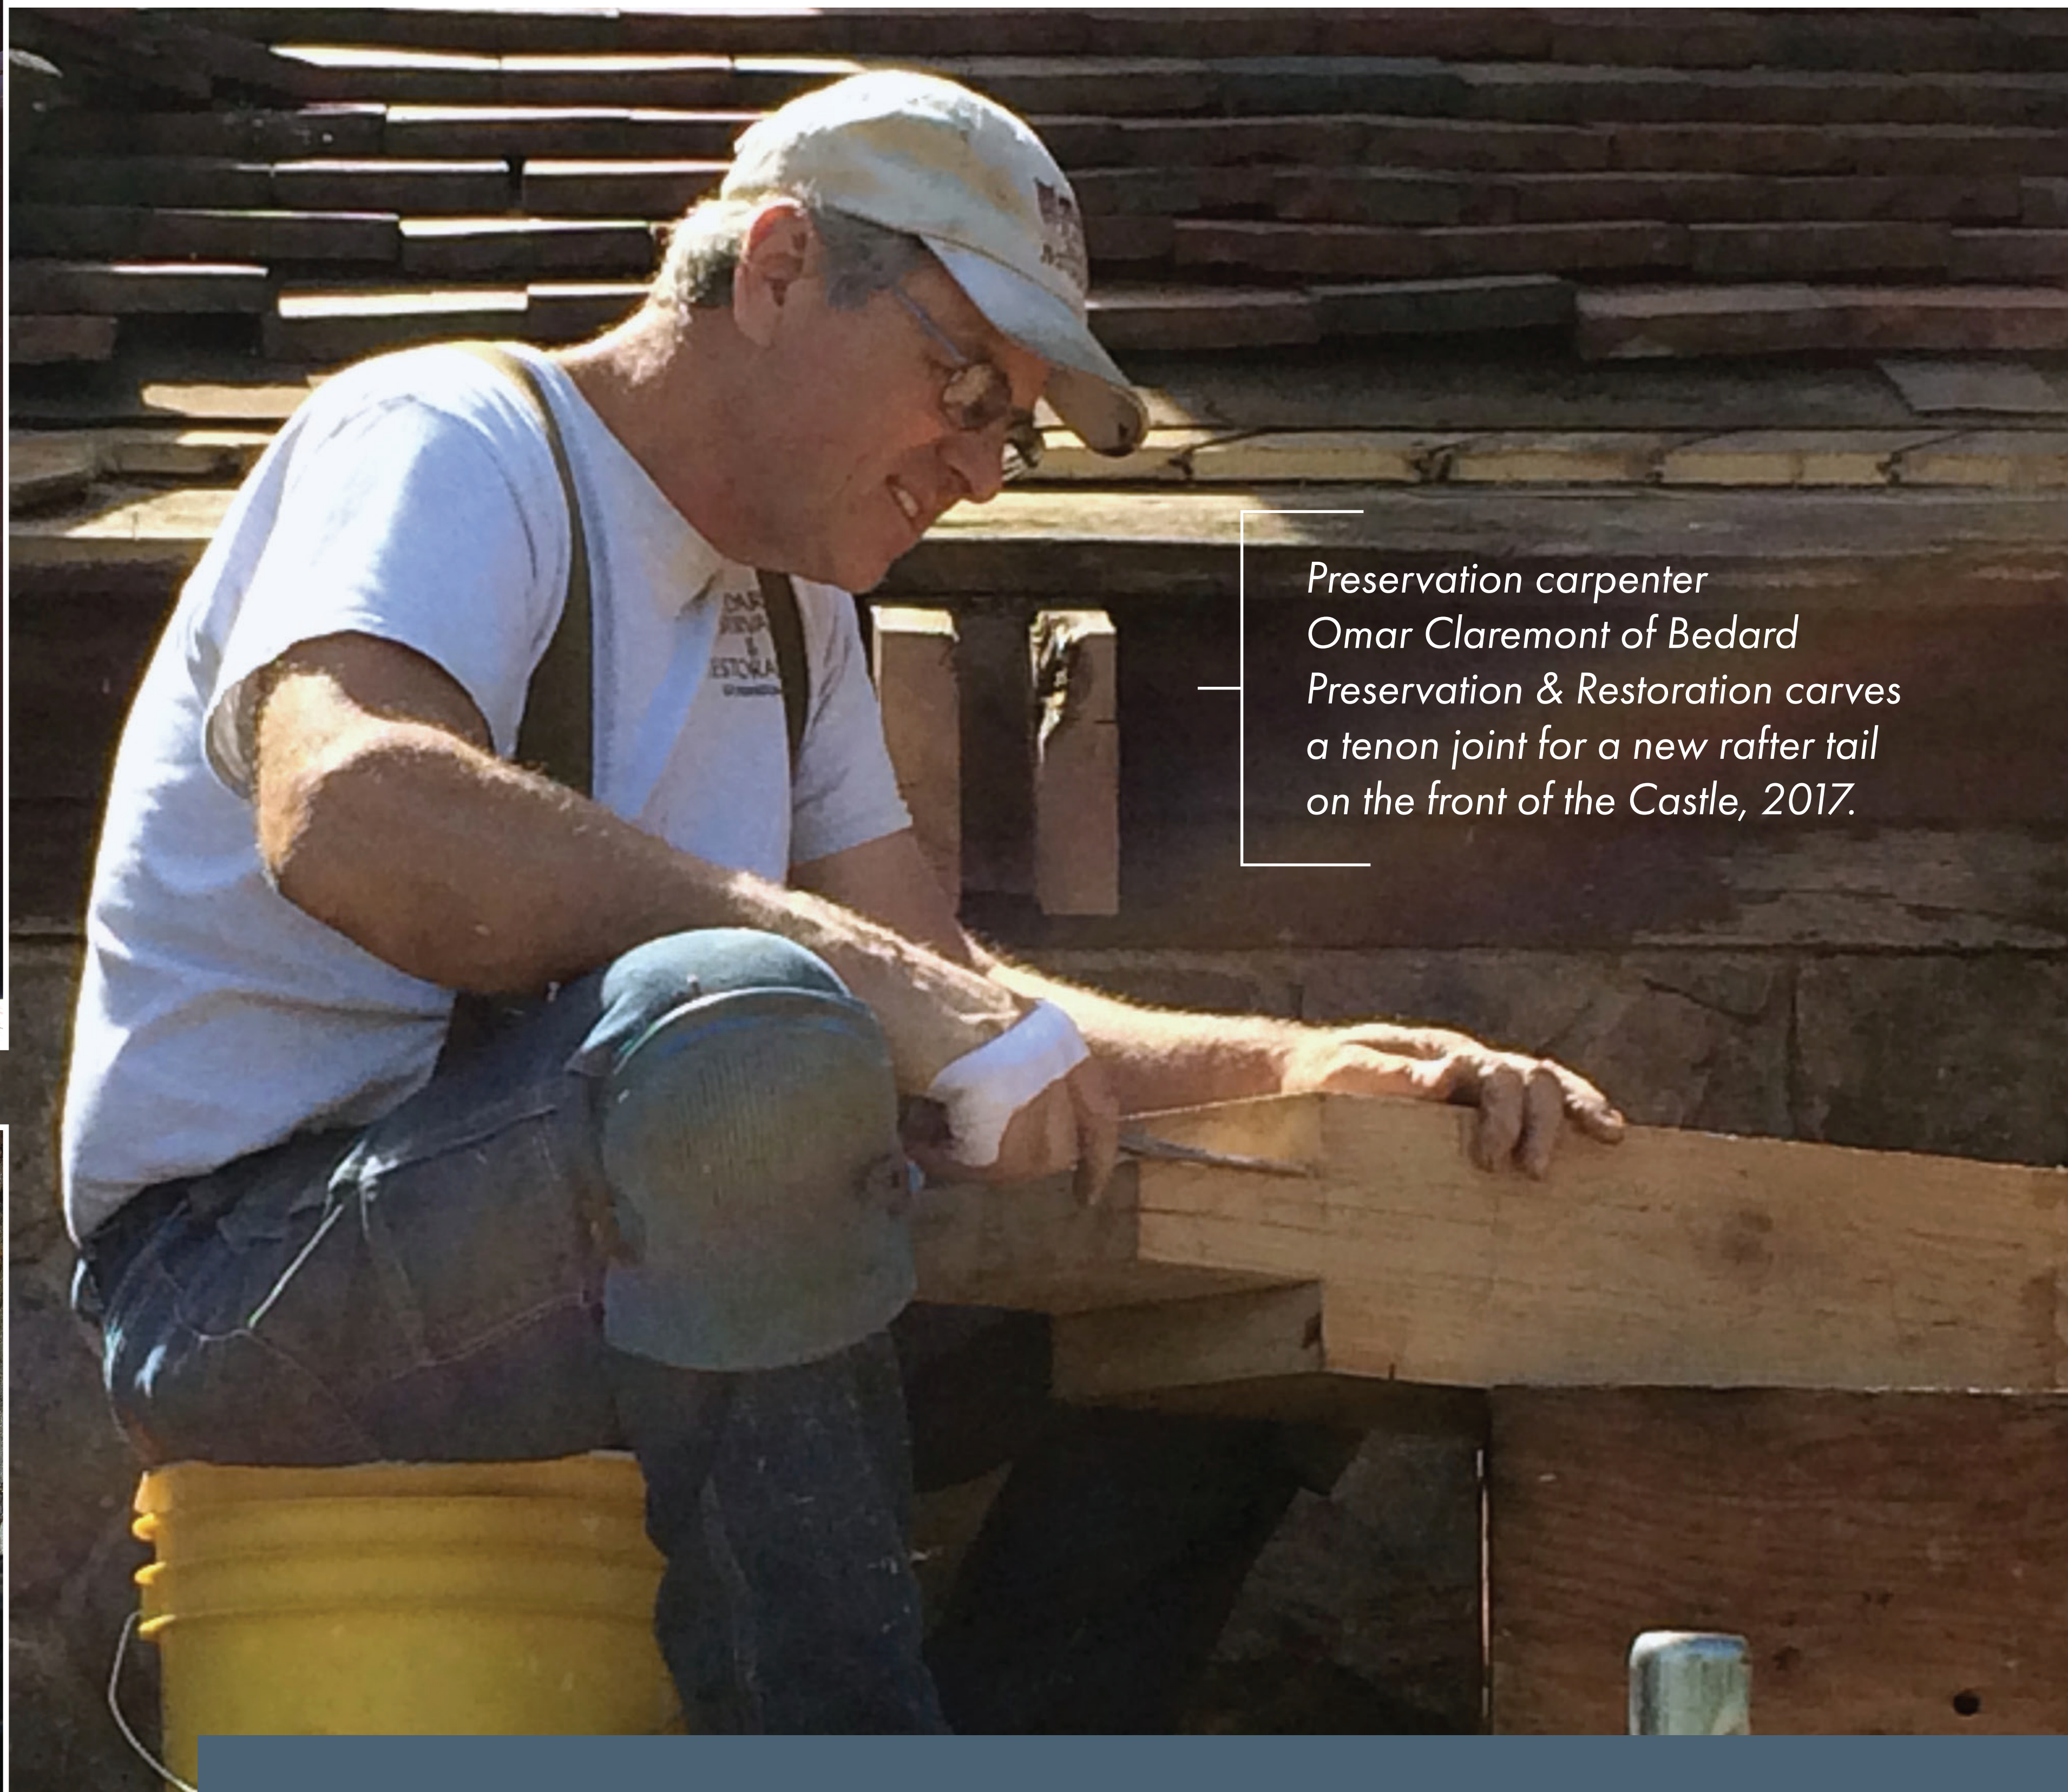
Preservation carpenter Omar Claremont of Bedard Preservation & Restoration carves a tenon joint for a new rafter tail on the front of the Castle, 2017.
