Portico Problems

The Castle's front portico was restored in 2013. Nearly all the wood supporting this porch structure had succumbed to water damage and rot and needed to be replaced. Preservation carpenters from Bedard Preservation & Restoration replaced the posts, beams, and all but one decorative wood brace with the same material and using the same construction methods as the original. New white oak timbers were attached with mortise and tenon joints and large dowels, and all exposed surfaces were scalloped with a chisel to recreate the portico's original handcrafted appearance. Masons completed the project by restoring the original quarry tile floor on the porch's balcony in 2016.

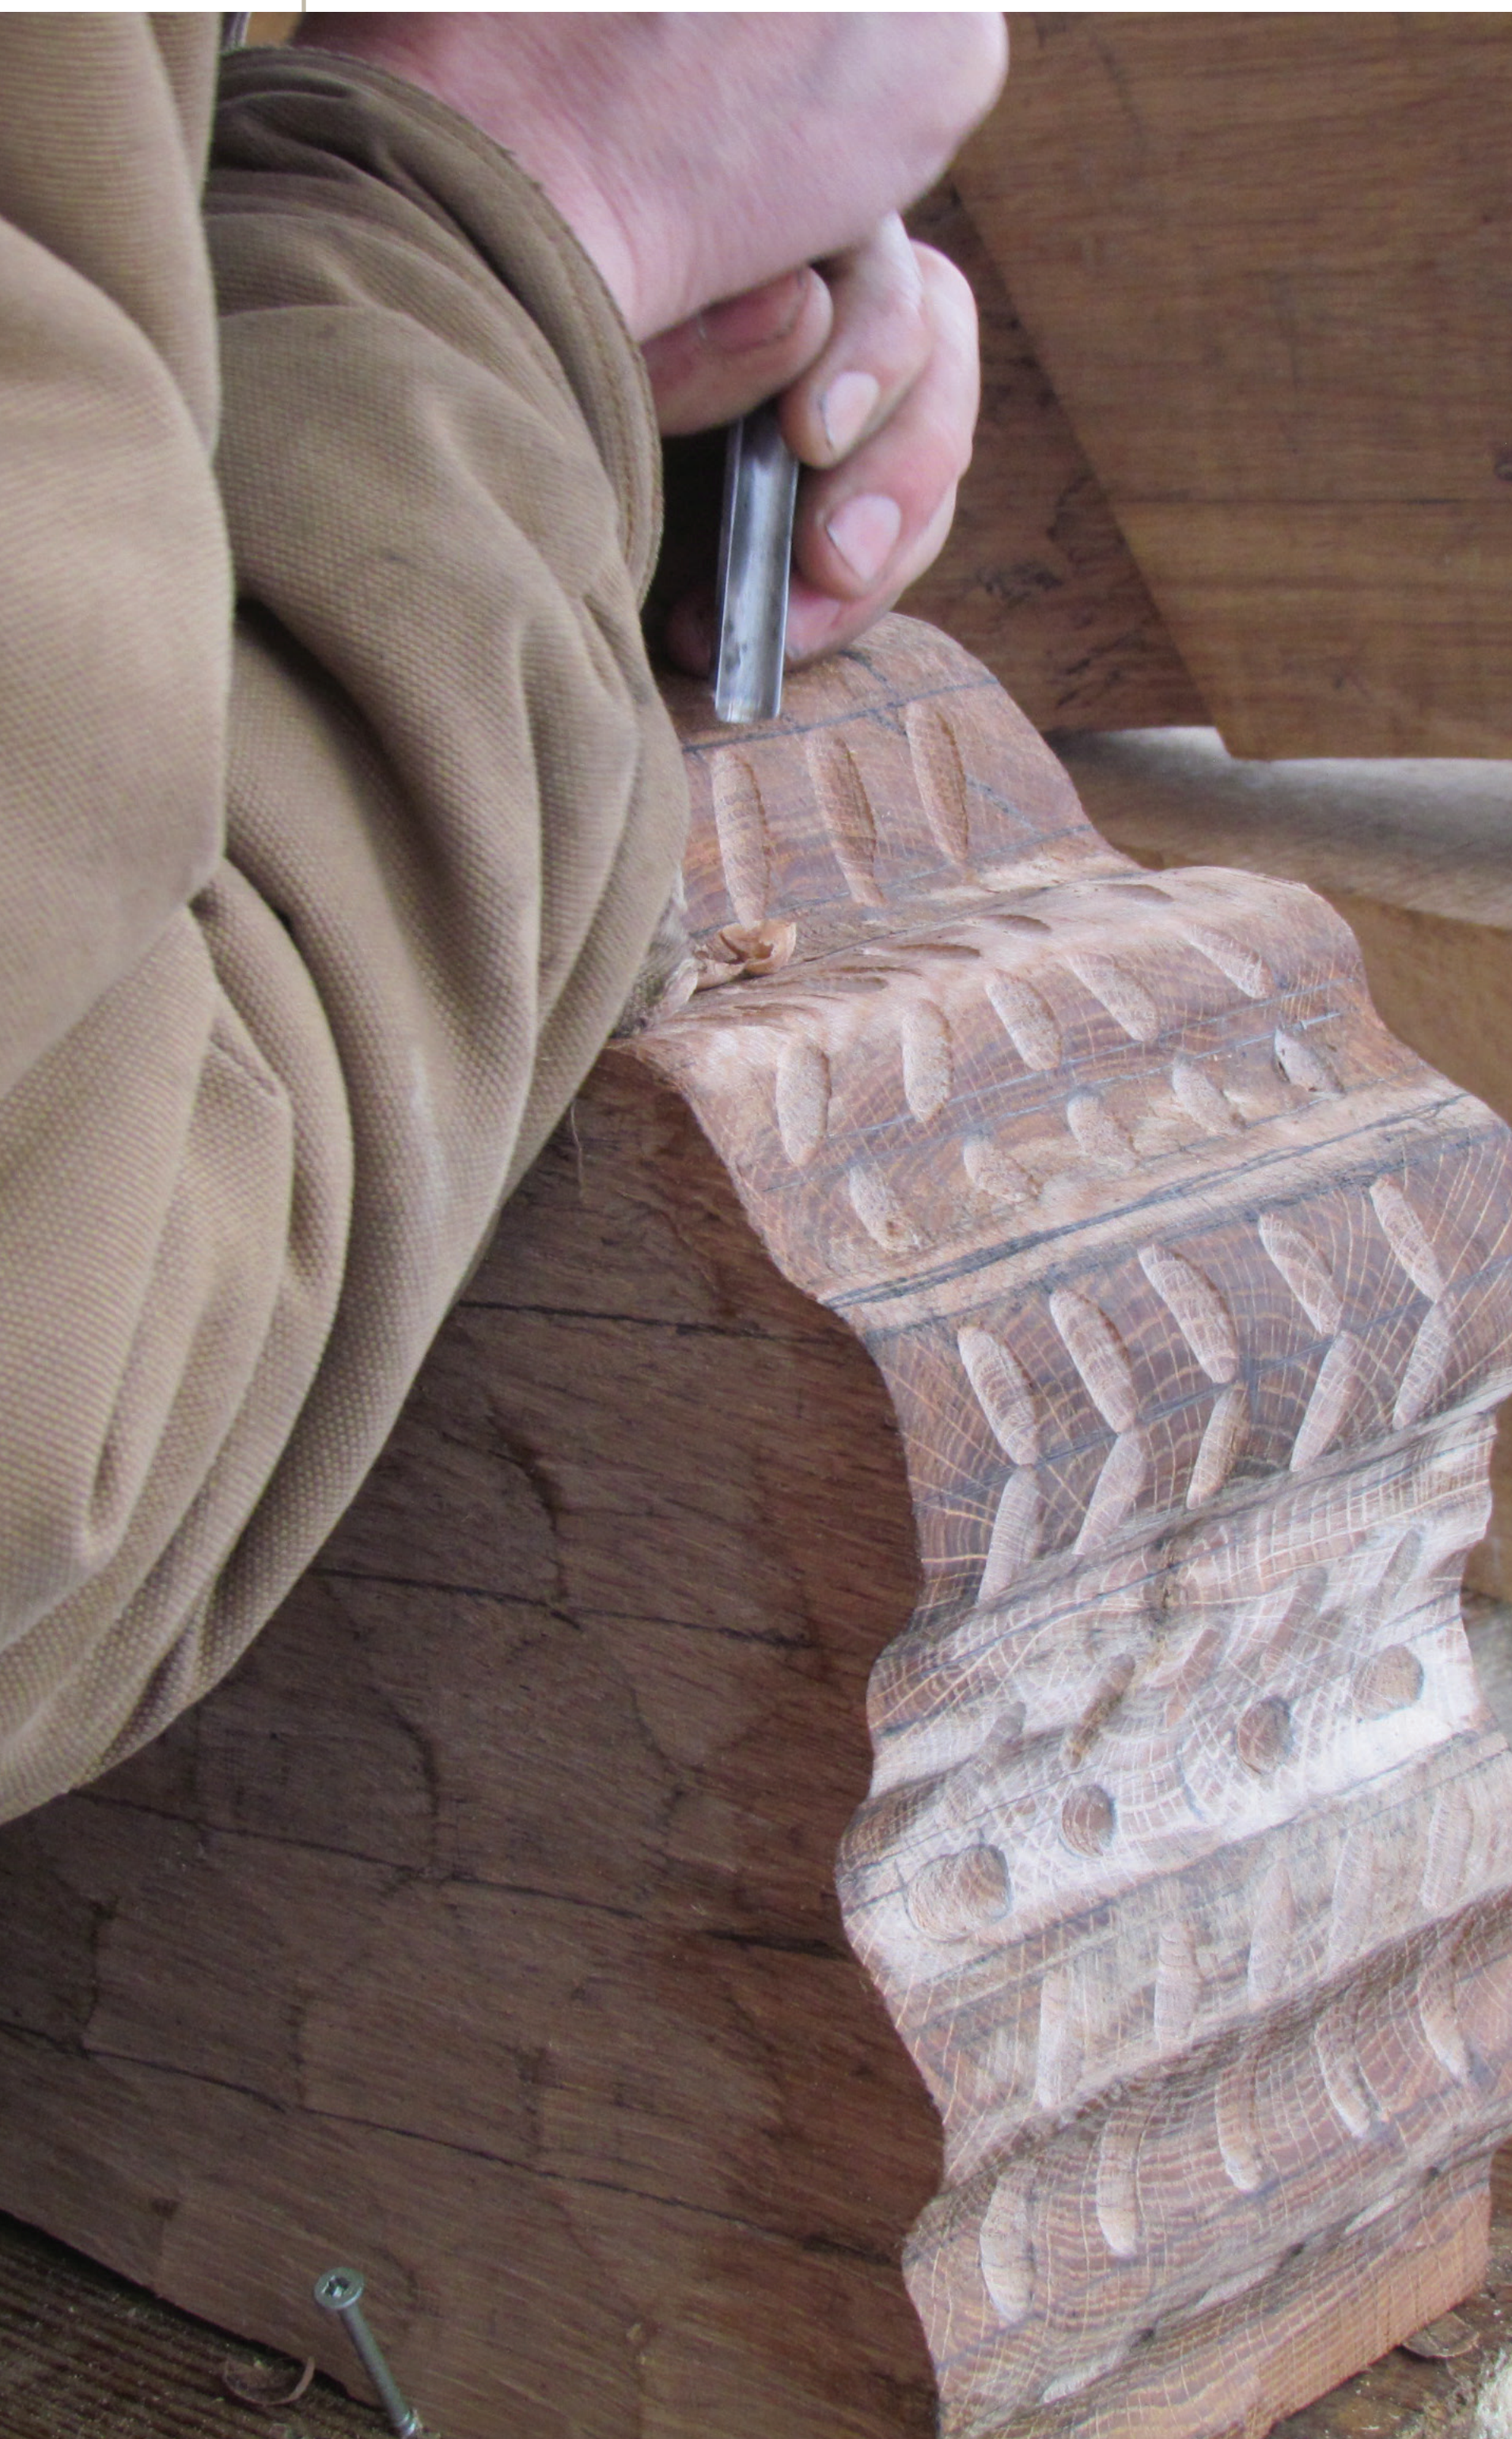
Restored portico at its unveiling in 2013. With the new replacement wood still unpainted, you can see the only original section of the portico that could be saved (see the brace at the upper left).

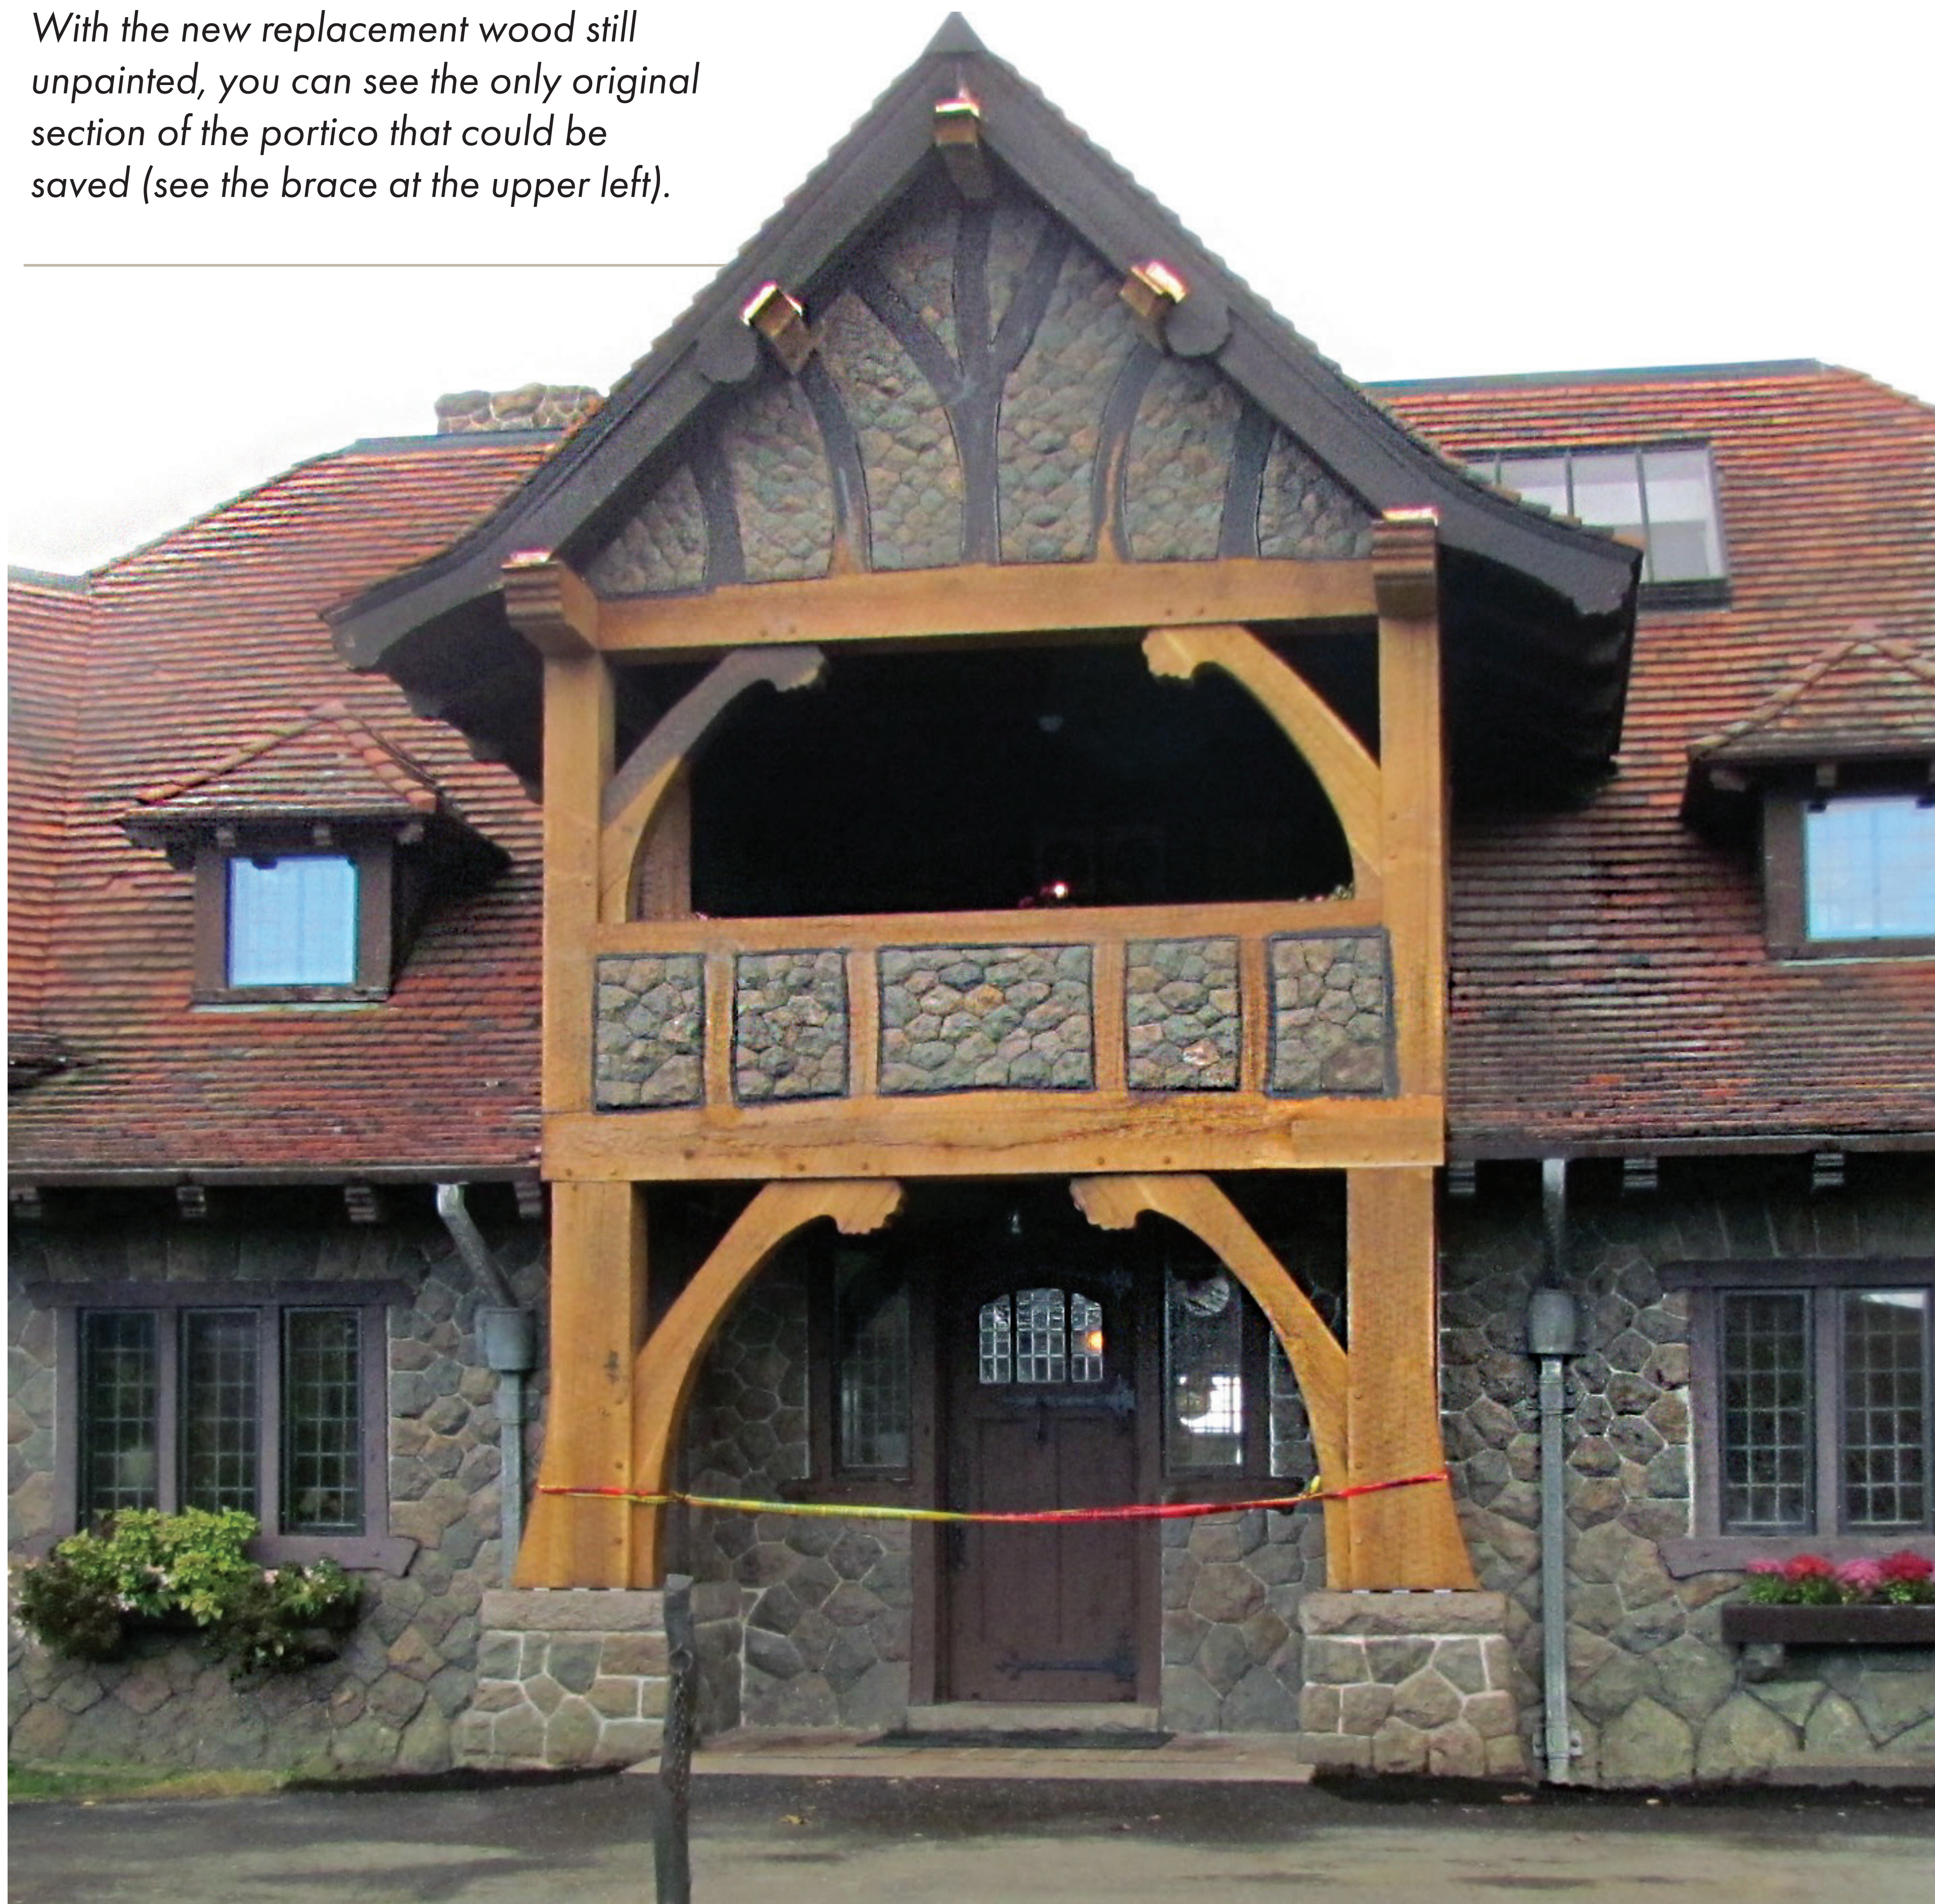
A carpenter from Bedard Preservation & Restoration skillfully chisels surface patterns into a replacement oak timber, replicating the original design.

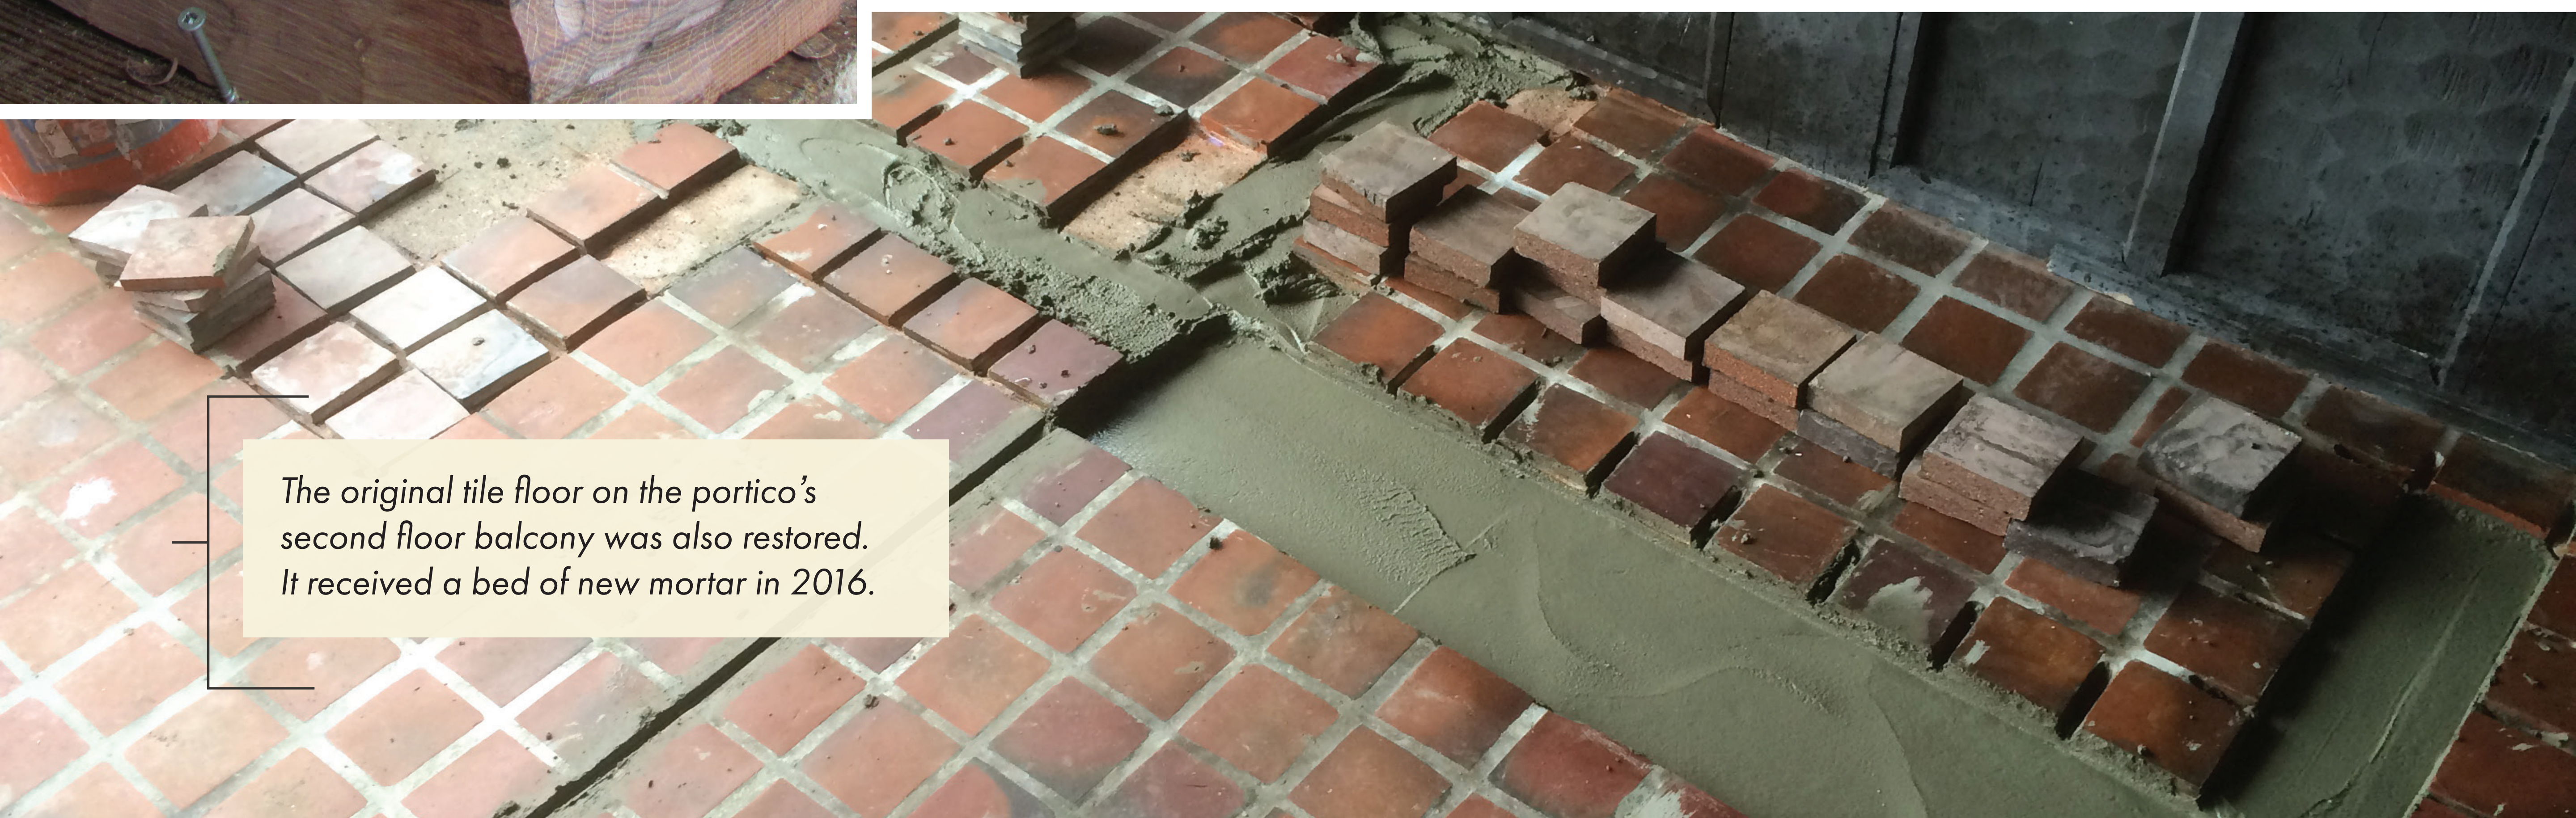
The original tile floor on the portico's second floor balcony was also restored. It received a bed of new mortar in 2016.
