Dining Room Restoration

Dining Room Ceiling Project 2015

Paneling and Flooring Restoration 2016-2017

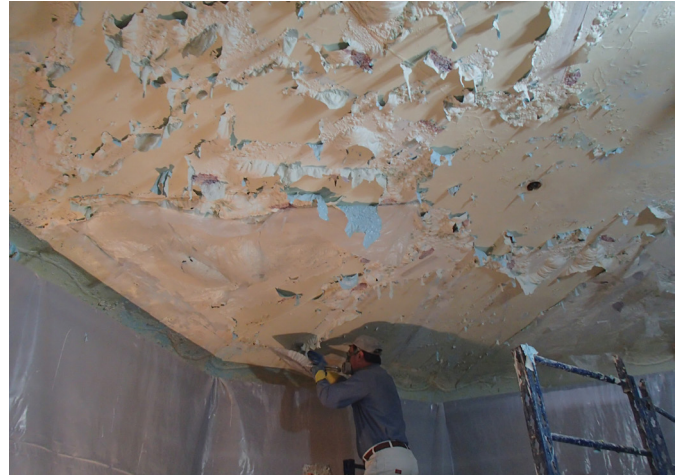
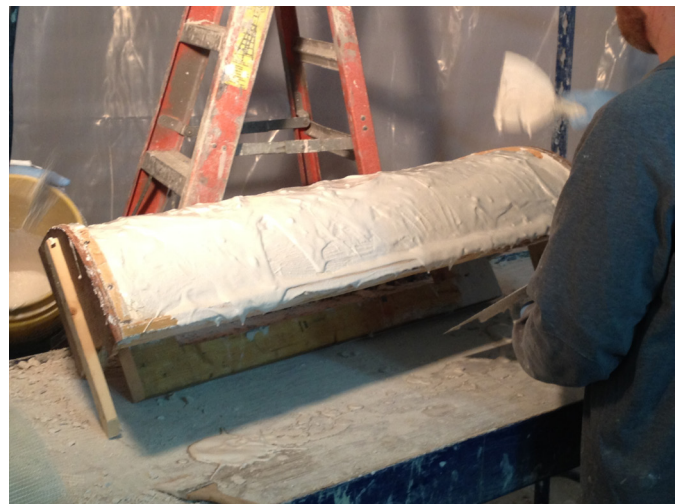
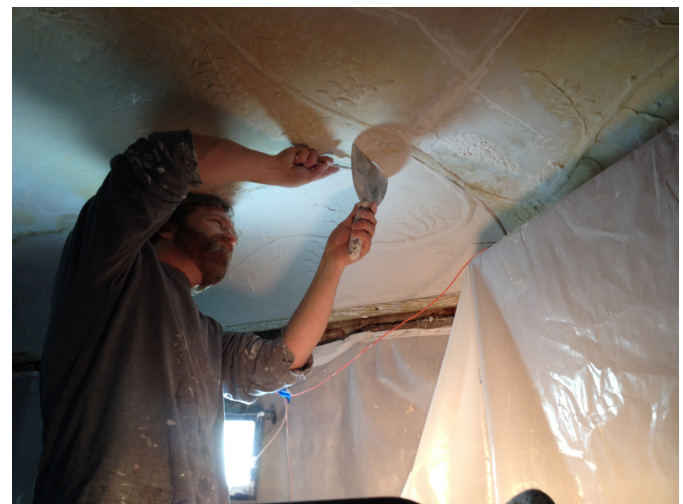
This plaster ceiling, an engineering feat, is constructed from over 50 separate cast pieces, all radiating out from the center and installed seamlessly when the house was first built.

In 2015, this ceiling was stabilized and fully restored. Layers of paint (including the most recent polychrome layer painted in the 1990s, and a mid-20th century sky blue layer) were carefully removed to reveal traces of the original cream color. Experts carefully scraped seven layers of paint from around the raised flowers and vine details, making the original details more pronounced.

Plaster experts also replaced two water-damaged panels from around the ceiling's perimeter (one above the fireplace, and one above the door to the left of the sideboard). After replacing the panels, the restoration crew repaired cracks between panel seams and stabilized the ceiling with hidden screws before applying a paint that matches the original color.

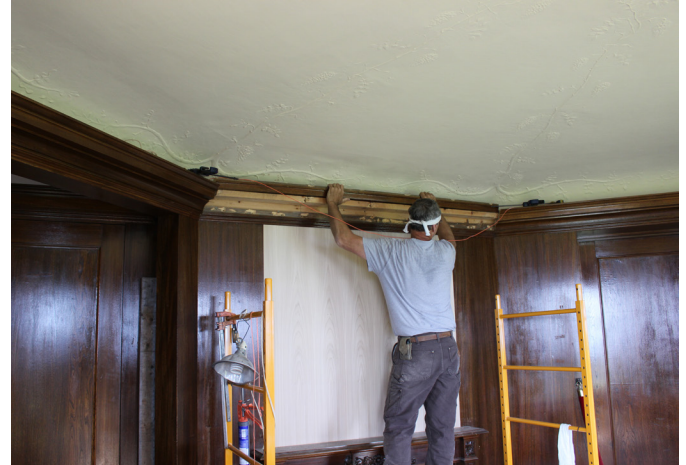
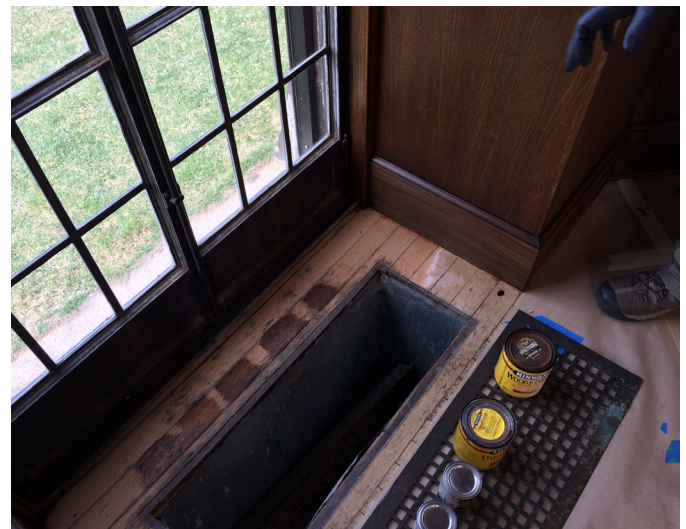
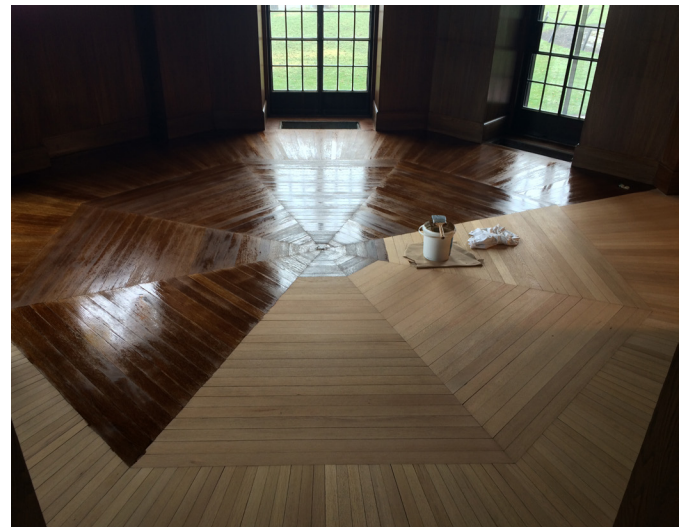
Within the last forty years, the paneling and flooring had been refinished and the original stain colors altered. Referencing historic photographs and traces of original stain around door frames and floor vents, a color and finish close to the original was selected. After a color was selected, the crew used gentle sanding equipment to remove modern finish while preserving the original wood underneath. The image right shows the floor halfway through re-staining.

The next step for our restoration contractors was to repair and replace sections of water damaged elm paneling around the south facing door and window frames, as well as above the mantle. A few panels had to be replaced, but most of the originals were saved. Elm wood with a similar grain to the original was sourced, and new wall panels were crafted in the same method as the original, using a paper thin elm veneer over plywood.
