Chimney Challenges

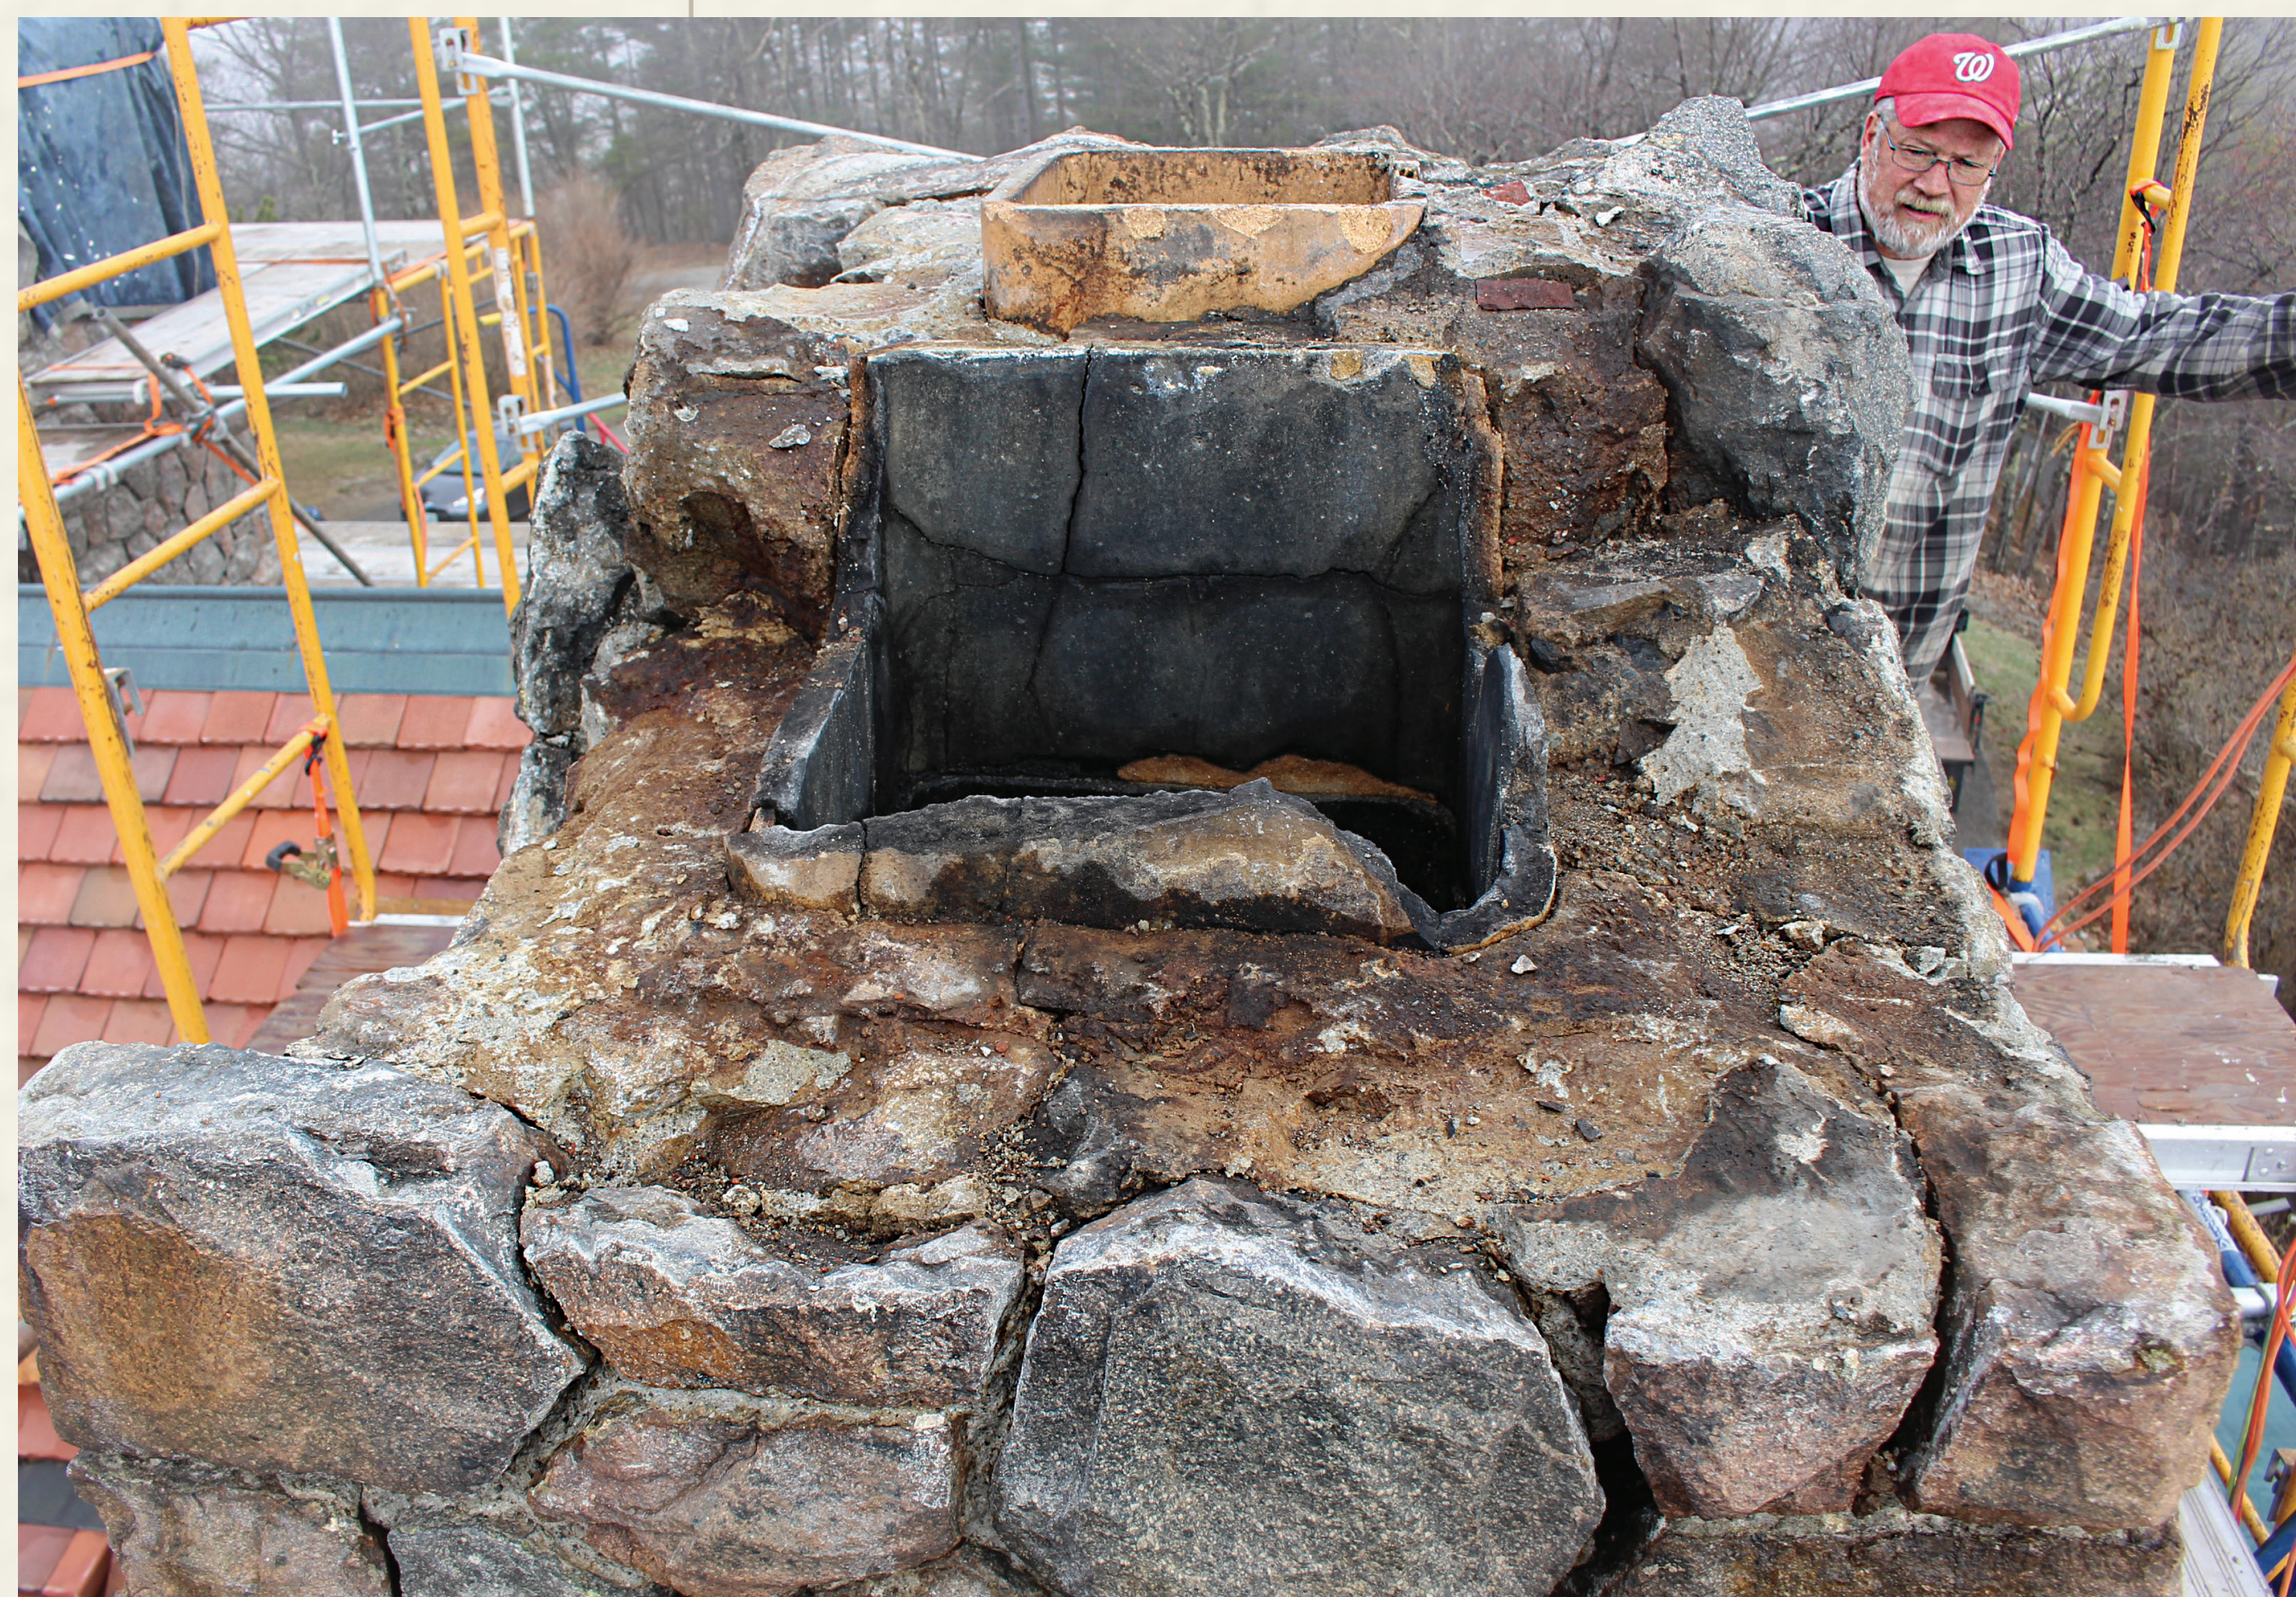
Tim of Stepping Stones Masonry examining the deterioration at the top of Chimney 1. This chimney vents the Castle's boilers and the fireplace in the sun parlor.

Three of Lucknow's four chimneys had succumbed to cracking and crumbling mortar over the years, resulting in rainwater entering the kitchen, library, and one of the guest bathrooms on the second floor. The Castle's team of restoration masons built sturdy scaffolding for each chimney project, then braved heights of up to 40 feet to repoint, repair, and cap the chimneys in 2016-2017. New copper flashing was added where the chimneys meet the terra cotta clad roof.

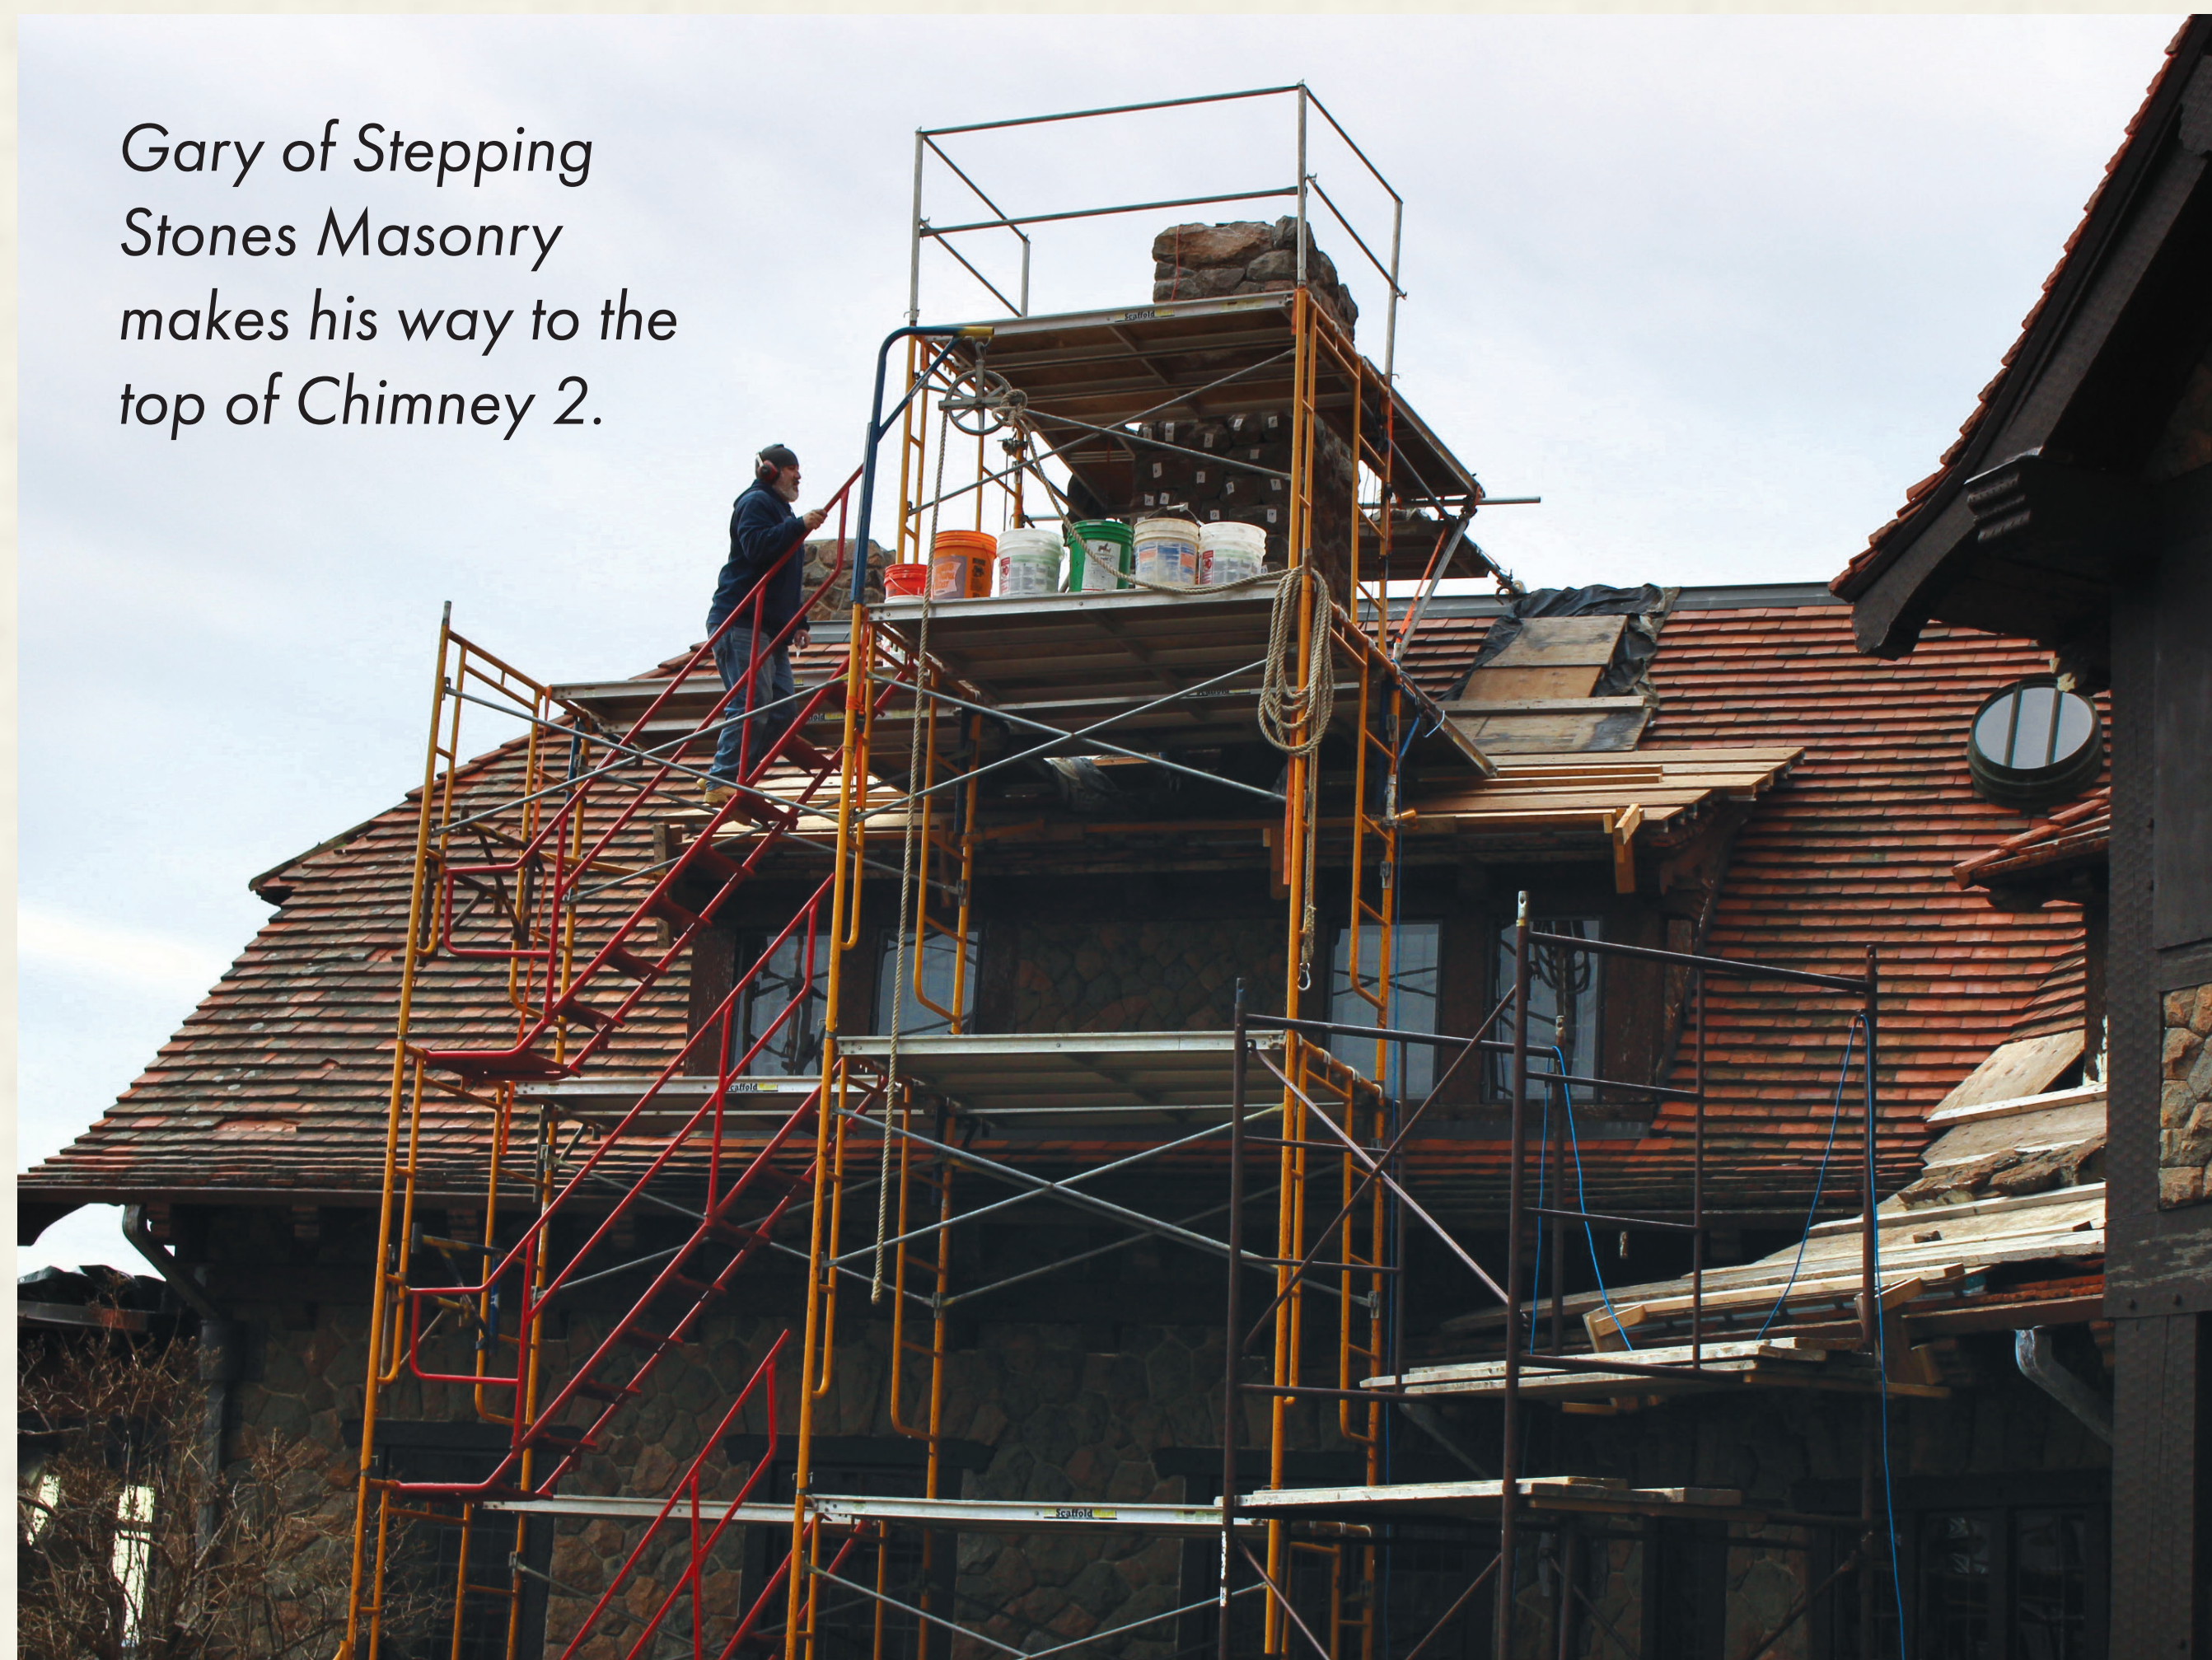
Chimney 2 stones are numbered and ready for removal so the mortar holding them together can be restored.
